# SERVICE NO. 1189 BULLETIN

Date: April 29, 2010

**STABILATOR HORN ASSEMBLY INSPECTION**

PA-24 Comanche  
PA-24-250 Comanche  
PA-24-260 Comanche  
PA-24-400 Comanche  
PA-30 Twin Comanche  
PA-39 Twin Comanche C/R

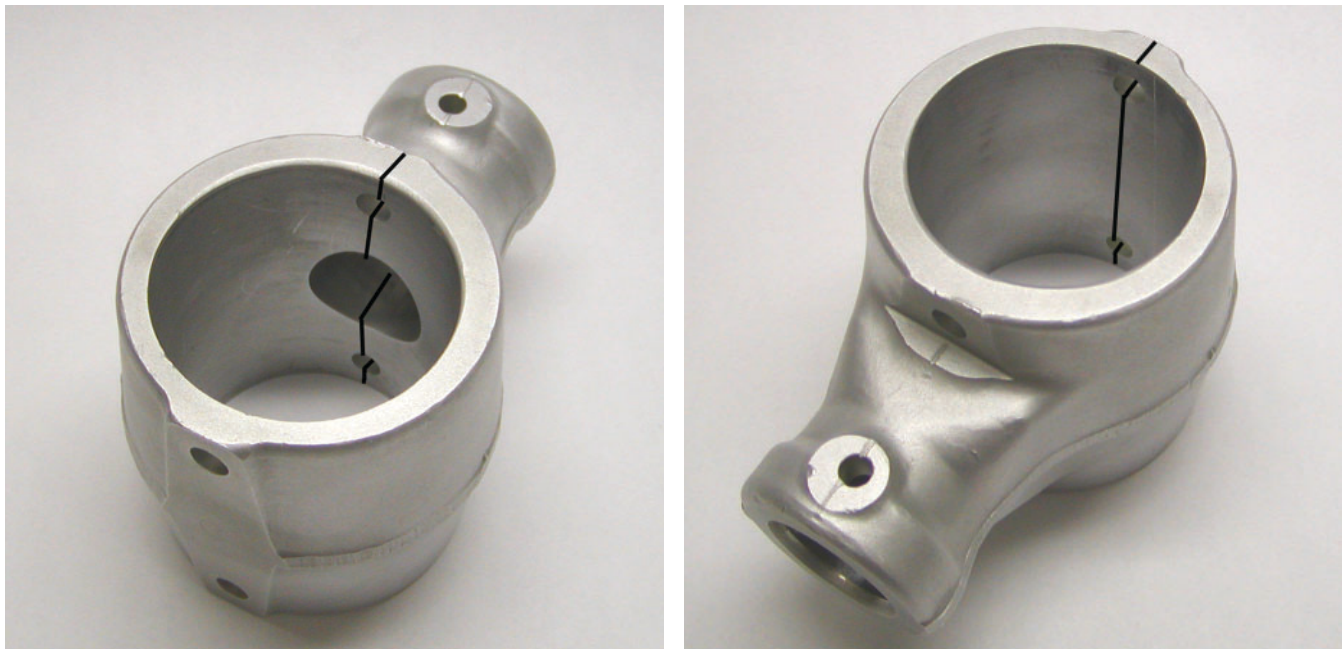
**Figure 1**  
**Lines indicate Inspection Area**

Reports have been received of cracks developing in the Stabilator Horn Assembly. Left uncorrected, this condition could cause separation of the Stabilator Horn from the Stabilator Torque Tube, leading to a reduction in pitch control.

**NOTE:** When cracks occur, they have been found to originate at an inner surface of the Stabilator Horn, as shown in Figure 1. Therefore, removal of exterior paint is not required for inspection. However, the Stabilator Horn **MUST** be removed from the Stabilator Torque Tube, in order to gain visual access to these areas.

2. Inspect the inside and outside of the Balance Weight Tube for signs of corrosion. No service limits exist for the outside diameter and wall thickness of this tube. Therefore, any measurable corrosion requires replacement of the Stabilator Horn Assembly.
3. Clean the inner surface of the Stabilator Horn with isopropyl alcohol, and perform dye penetrant inspection per AC 43.13-1B (Aircraft Inspection and Repair Manual), with specific emphasis on the areas denoted by heavy lines in Figure 1.

4. If cracking or corrosion is discovered in the Balance Weight Tube or Stabilator Horn, order and install a replacement Stabilator Horn Assembly. Refer to Table 1 for the applicable part number.
