SERVICE NO. 1200 BULLETIN

Date: May 29, 2009 (S)

SUBJECT: LANDING GEAR MODIFICATION AND HARDWARE REPLACEMENT

PA-38-112 Tomahawk

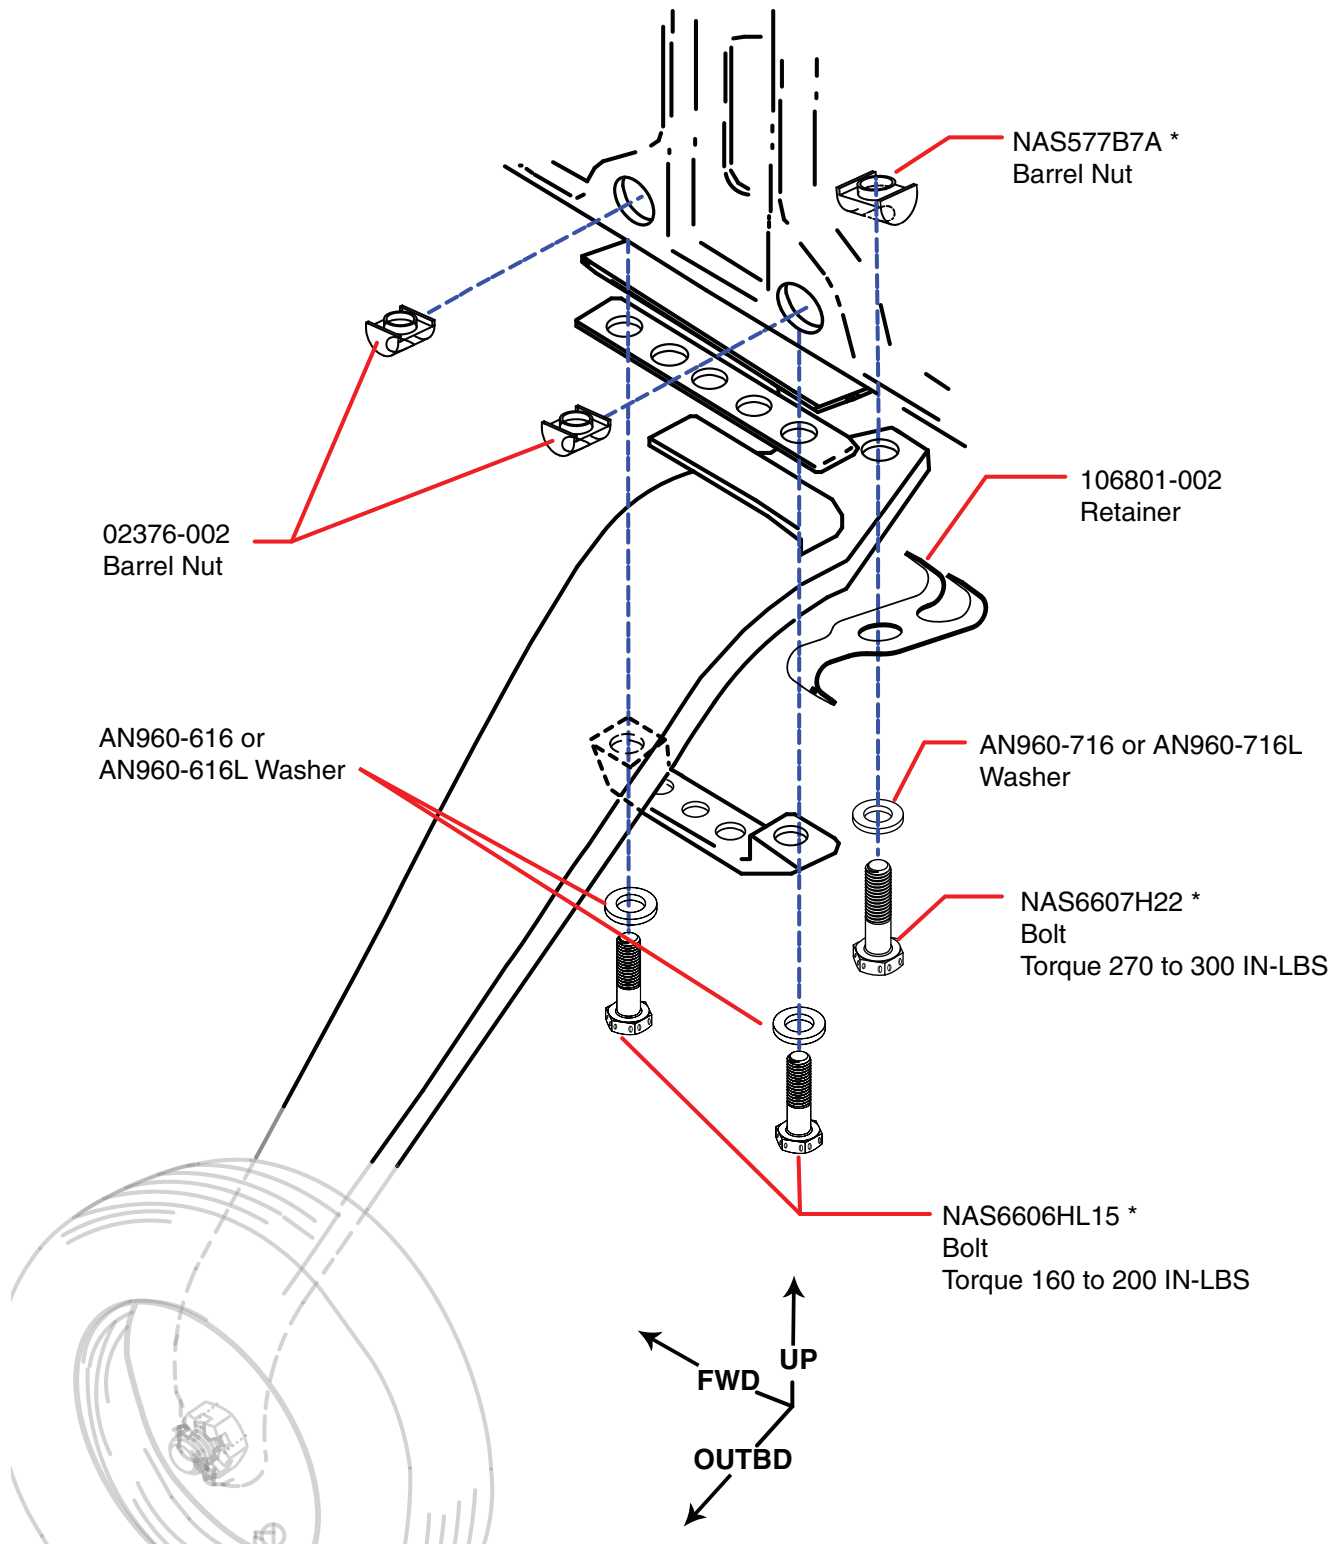
Figure 1
Main Landing Gear
LH shown, RH opposite
Main Landing Gear Fairing Omitted For Clarity

PURPOSE: An examination of the Tomahawk aircraft service history reveals that the bolts securing the main landing gear to the airframe can bend or break when subjected to repeated high loading conditions, resulting in landing gear failure.

4. Install new replacement hardware, as shown in Figure 1 and as listed in Materials Required - **Table 4**. All other components that are free of damage or corrosion may be re-used at their original locations. Torque bolts according to the following procedure:

- a) Draw up pairs of NAS6606HL15 bolts evenly, 1 or 2 turns maximum per bolt, alternating back and forth until bolts are snug. Install (1 each side) NAS6607H22 bolt, and tighten until snug. Torque should build up gradually for all bolts. An abrupt buildup indicates threads are bottoming in the barrel nut.

- b) With all bolts installed and snug, torque the (2 each side) NAS6606HL15 bolts 160 to 200 inch-pounds, and torque the (1 each side) NAS6607H22 bolts 270 to 300 inch-pounds. Examine bolt thread penetration during and after torquing.

- For the (2 each side) NAS6606HL15 bolts, the end of bolt must be at least flush with barrel nut after torquing. If bolt extends into clearance hole, or threads bottom out as described above, add additional AN960-616 or AN960-616L washer under bolt head to achieve proper bolt grip. The saddle clamp and shim should fit snugly against the wing. See **Table 1** for interchangeability with NAS1149 washers.

- For the (1 each side) NAS6607H22 bolts, at least one complete bolt thread must protrude visibly through the barrel nut after torquing. If bolt extends into clearance hole, or threads bottom out as described above, add additional AN960-716 or AN960-716L washer under bolt head to achieve proper bolt grip. See **Table 1** for interchangeability with NAS1149 washers.
