# SERVICE NO. 1304 BULLETIN

Date: August 23, 2017

**MAIN WING SPAR INSPECTION**

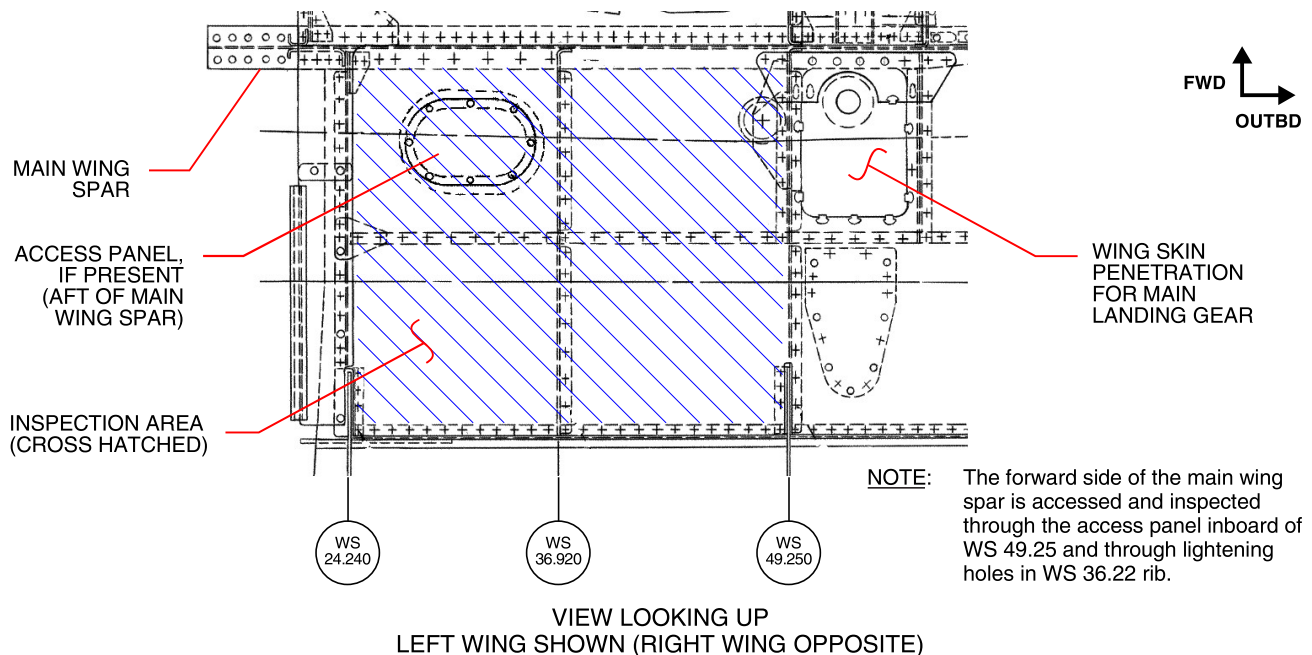
**Figure 1**  
Access Panel Location

1. RC – Examine the lower wing skin in the area shown in Figure 1 for the presence of an access panel, which is in the area aft of the main wing spar and inboard of the main landing gear. This access panel, if present, will be oval shaped, roughly eight (8) inches long and 5.50 inches wide.
  - If an access panel already exists in the area identified in Figure 1, proceed to Step 2.
  - If no access panel exists in the area identified in Figure 1, order and install Inspection Access Hole Kit, Piper Part Number (P/N) 765-106V. Each kit provides parts to install one access panel on the lower surface of both the left and right wings, at a location that provides direct visual access to the inspection area. Proceed to Step 2.

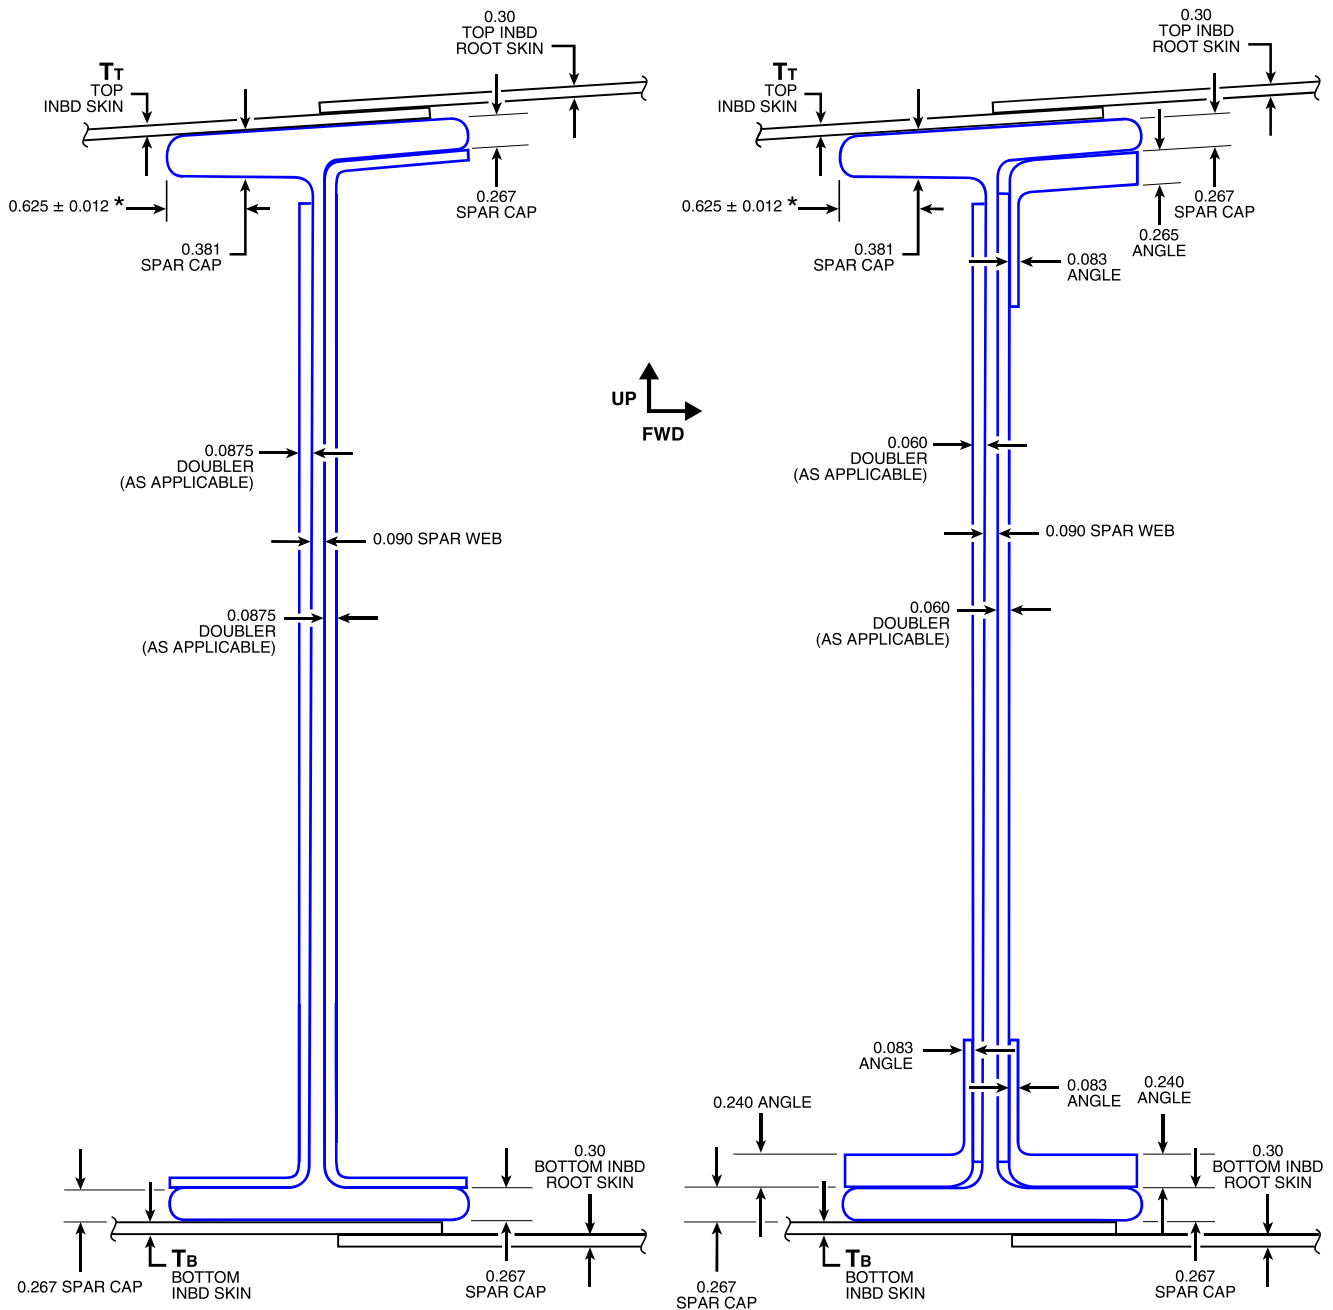
**Figure 2, Sheet 2 of 2**  
Wing Spar Configurations

**NOTE:** The minimum allowable dimensions are shown in View A-A and B-B, except as denoted by \*.

\* The dimension 0.625 +/- 0.012 is not a measure of material thickness. Rather, this dimension defines the location to measure for the minimum allowable thickness of 0.381 in the spar cap.

5. RC – After removal of the corrosion, verify that all affected areas meet or exceed the minimum thicknesses stated within this service bulletin. At locations where direct measurement is not possible, thickness measurements shall be accomplished using a nondestructive inspection method such as ultrasound, eddy current, or equivalent, provided that such method achieves a measurement accuracy of +/- 0.005 inches or better.
