Piper Aircraft, Inc.  
2926 Piper Drive  
Vero Beach, FL, U.S.A. 32960

# SERVICE NO. 1345A BULLETIN

Date: September 17, 2021

### MAIN WING SPAR INSPECTION

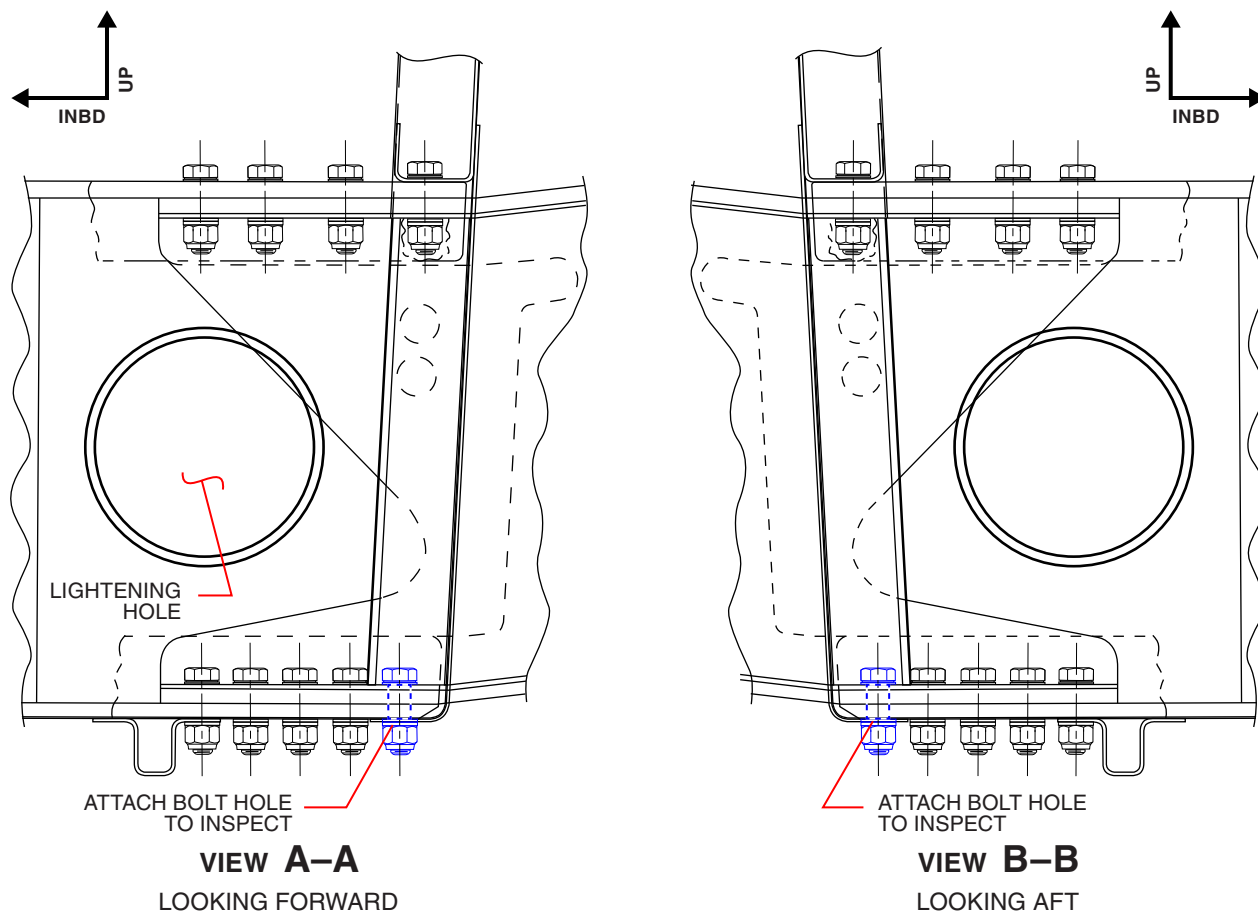
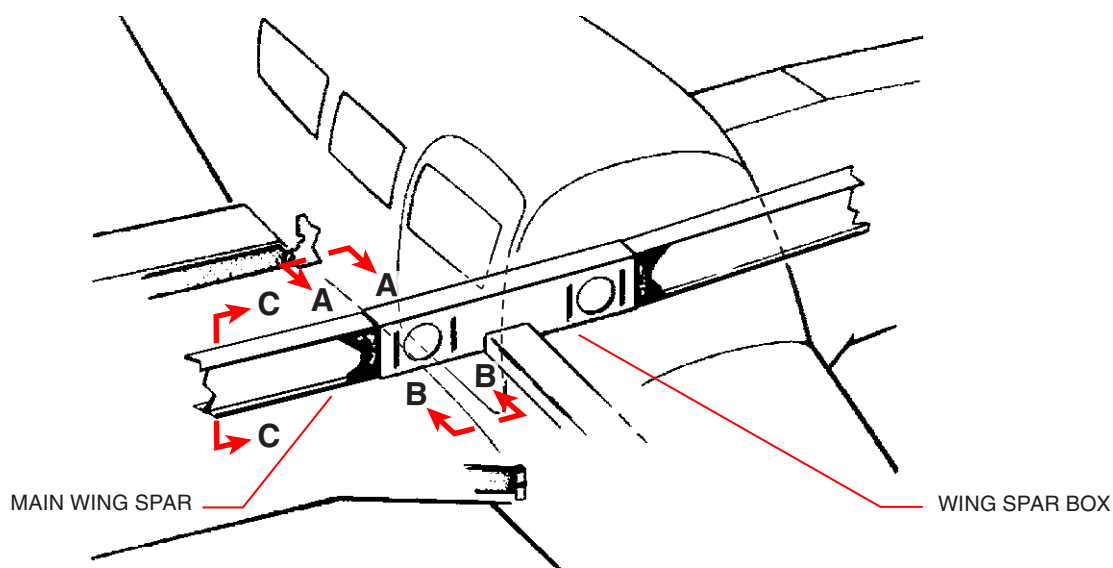
**Figure 1, Sheet 1 of 2**  
Typical Main Wing Spar Attach Bolts and Spar Cross Section (Right Wing Shown)

3. Inspect the inner surface of each bolt hole in the lower wing spar cap. Figure 1 provides cross sections of the main wing spar, and identifies the bolt hole inspection areas.

**WARNING:** Do not drive bolts into or out of the main spar attaching bolt holes (see Views A-A and B-B). Be careful to avoid damaging the bolt holes while removing and replacing the bolts. Refer to "Care for Bolts and Bolt Holes" in this service bulletin.

**NOTE:** When radius washers are properly installed, the radius feature of the washer will be oriented to match the radius of the adjacent structure, as shown in Figure 1, Detail D.
