**[Docket No. FAA–2022–0891; Project Identifier AD–2022–00585–A,E,R; Amendment 39–22432; AD 2023–09–09]**

### **Airworthiness Directives; Various Airplanes, Helicopters, and Engines**

Final rule.

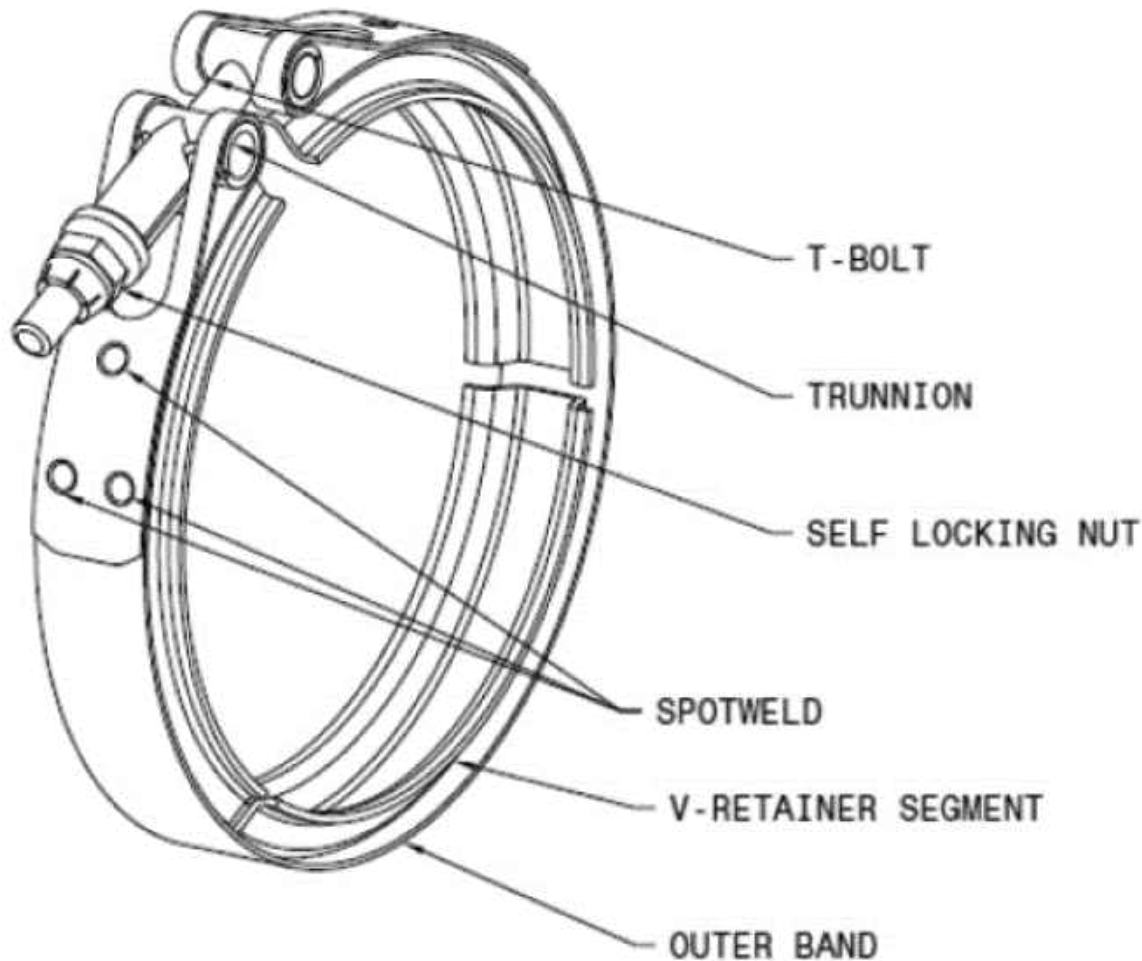
**Figure A**

The final report concluded that the common denominator in the incidents and accidents reviewed is the spot-welded, multi-segment exhaust tailpipe v-band coupling (see Figure A). These couplings come in either two or three segment varieties. The segments are the number of v-retainer segments,

**Spot-welded, multi-segment exhaust tailpipe v-band coupling**

The majority of the events studied by the working group indicated fatigue failure of spot-welded, multi-segment exhaust tailpipe v-band couplings as a result of stress corrosion cracking that originated at or near a spot weld. This is the same unsafe condition identified in the other v-band coupling AD actions previously referenced. The data studied by the working group contained evidence of pre-existing cracking of the couplings, known embrittlement at the spot weld locations simply due to that manufacturing method, and outer band cupping on the multi-segment couplings (which is the result of age, over-use, and potential over-torquing). The working group also found that many of the couplings had safety wire across the bolt end. The safety wire could be helpful if there was a bolt or nut failure (extremely rare events) or the nut was missing. However, the safety wire was of no value when the failure was transverse band cracking and total separation at the spot weld. The data studied by the working group indicated many accidents were due to v-band couplings that were of the multi-segment, spot-welded design, when used in a specific location (the tailpipe to the turbocharger exhaust housing flange on turbocharged reciprocating engine-powered aircraft).

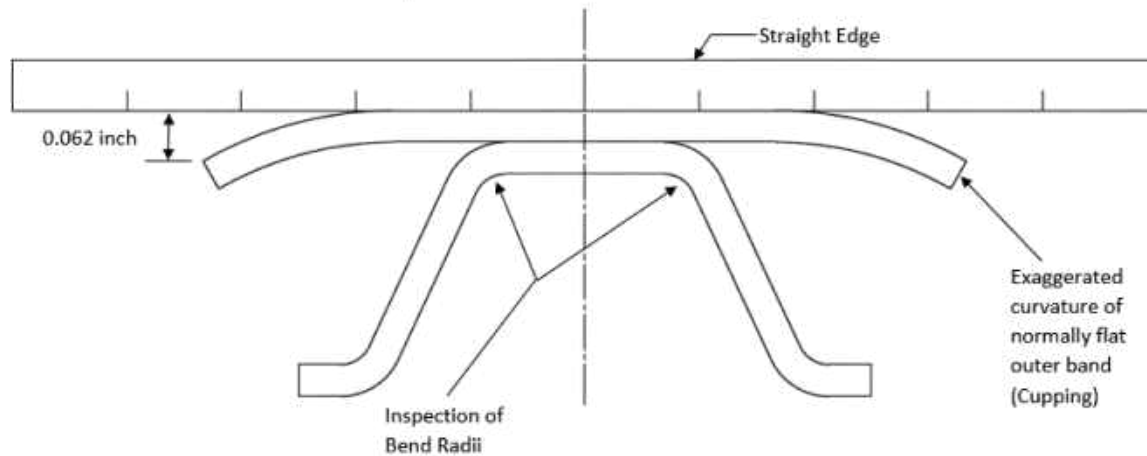
Figure 1 to paragraph (l)(1)(iii) – Inspection Depiction

(iii) Visually inspect the flatness of the outer band using a straight edge. Lay the straight edge across the width of the outer band as depicted in figure 1 to paragraph (l)(1)(iii) of this AD. If the gap between the outer band and the straight edge exceeds 0.062 inch, before further flight, remove the v-band coupling from service and install a new v-band coupling.

(v) Visually inspect the bend radii of the v-retainer coupling segments, throughout the length of the segment, as depicted in figure 1 to paragraph (l)(1)(iii) of this AD, for cracks. If there are any cracks, before further flight, remove the v-band coupling from service and install a new v-band coupling.
