Piper Aircraft, Inc.  
2926 Piper Drive  
Vero Beach, FL, U.S.A. 32960

# SERVICE NO. 1345 BULLETIN

Date: March 27, 2020

**MAIN WING SPAR INSPECTION**

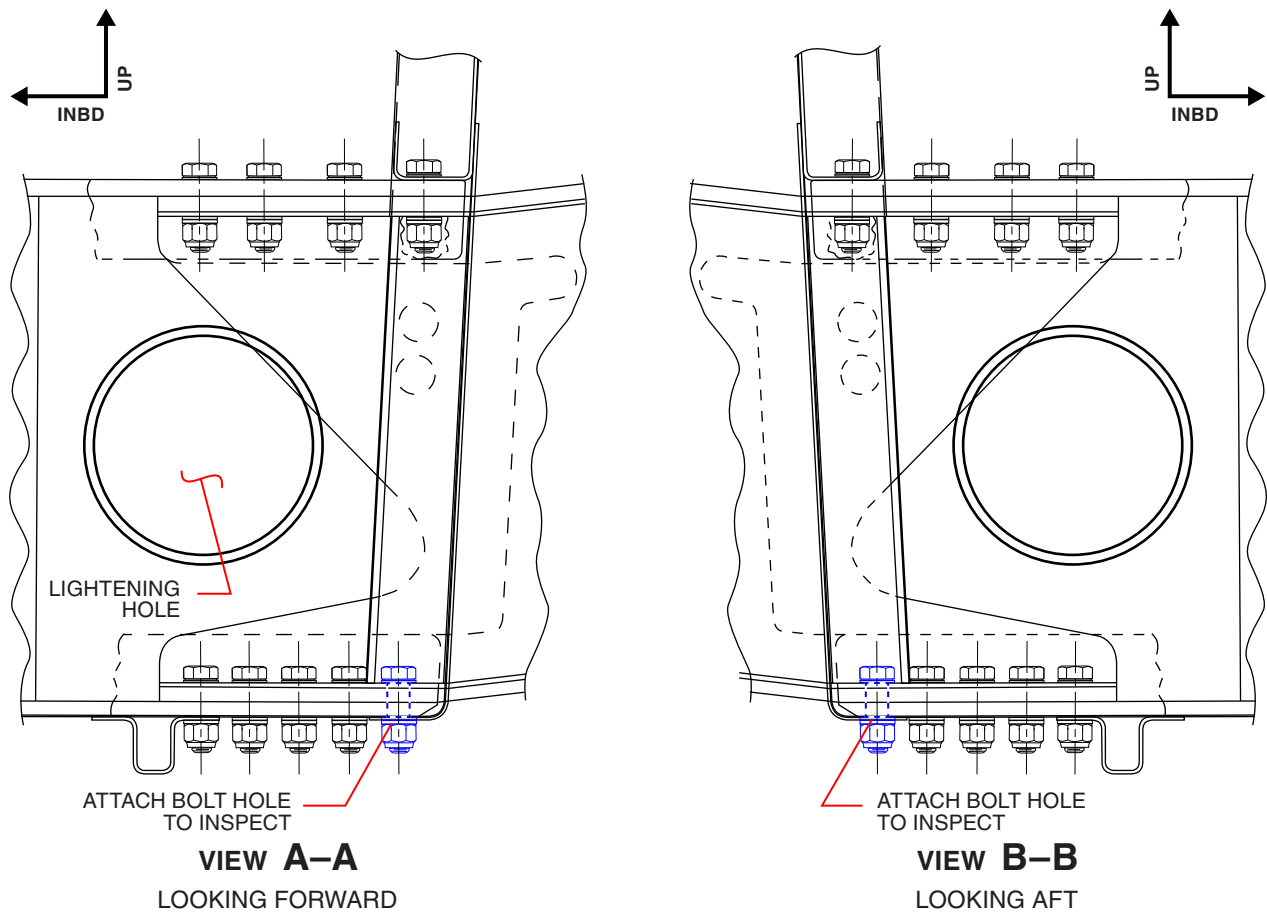
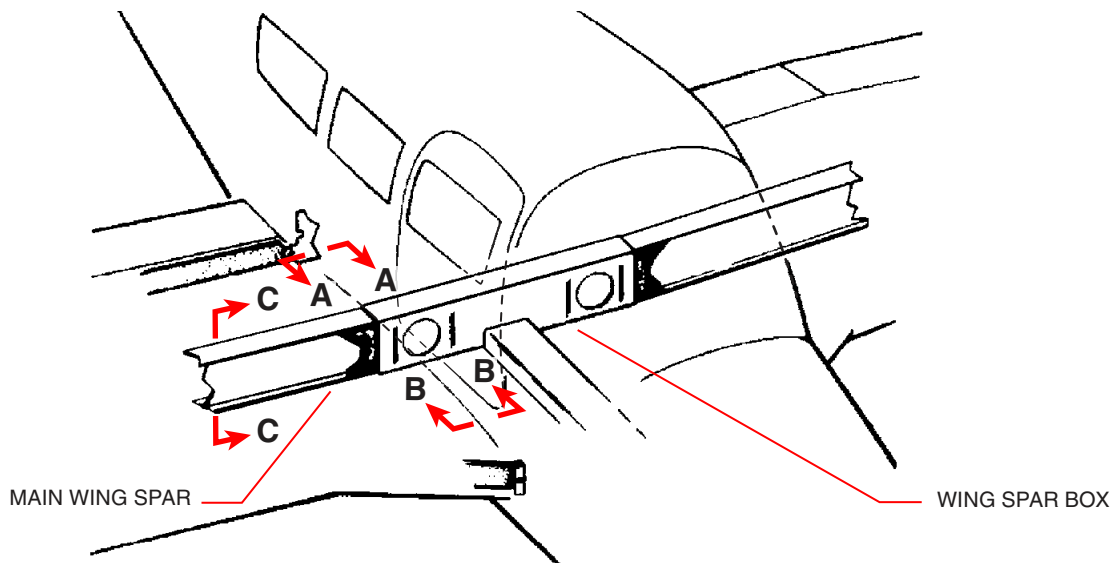
**Figure 1, Sheet 1 of 2**  
Typical Main Wing Spar Attach Bolts and Spar Cross Section (Right Wing Shown)

1. Locate the two (2) outermost main spar attach bolts, as shown in Figure 1, installed on the lower cap of the left and right main spar, on the forward and aft sides of the spar web.

**WARNING:** Do not drive bolts into or out of the main spar attaching bolt holes (see Views A-A and B-B). Be careful to avoid damaging the bolt holes while removing and replacing the bolts.

2. Carefully remove the two (2) wing spar attach bolts. Discard the bolts and nuts. Retain or replace the washers, depending on condition.
3. Inspect the inner surface of each bolt hole using the eddy current inspection method described above. Figure 1 provides cross sections of the main wing spar showing the bolt holes to be inspected.
4. Fill out the inspection [feedback form \(link\)](#), regardless of the findings.
  - If no cracks are found, return the form to Piper within 10 business days. Proceed to Step 6.
  - If any cracks are found, return the form to Piper within 24 hours (or one business day). Proceed to Step 5.
5. Prior to further flight, replace the wing, spar or spar section, as applicable, with a serviceable unit that has been shown to be free of cracks when subjected to the inspections specified in this service bulletin.

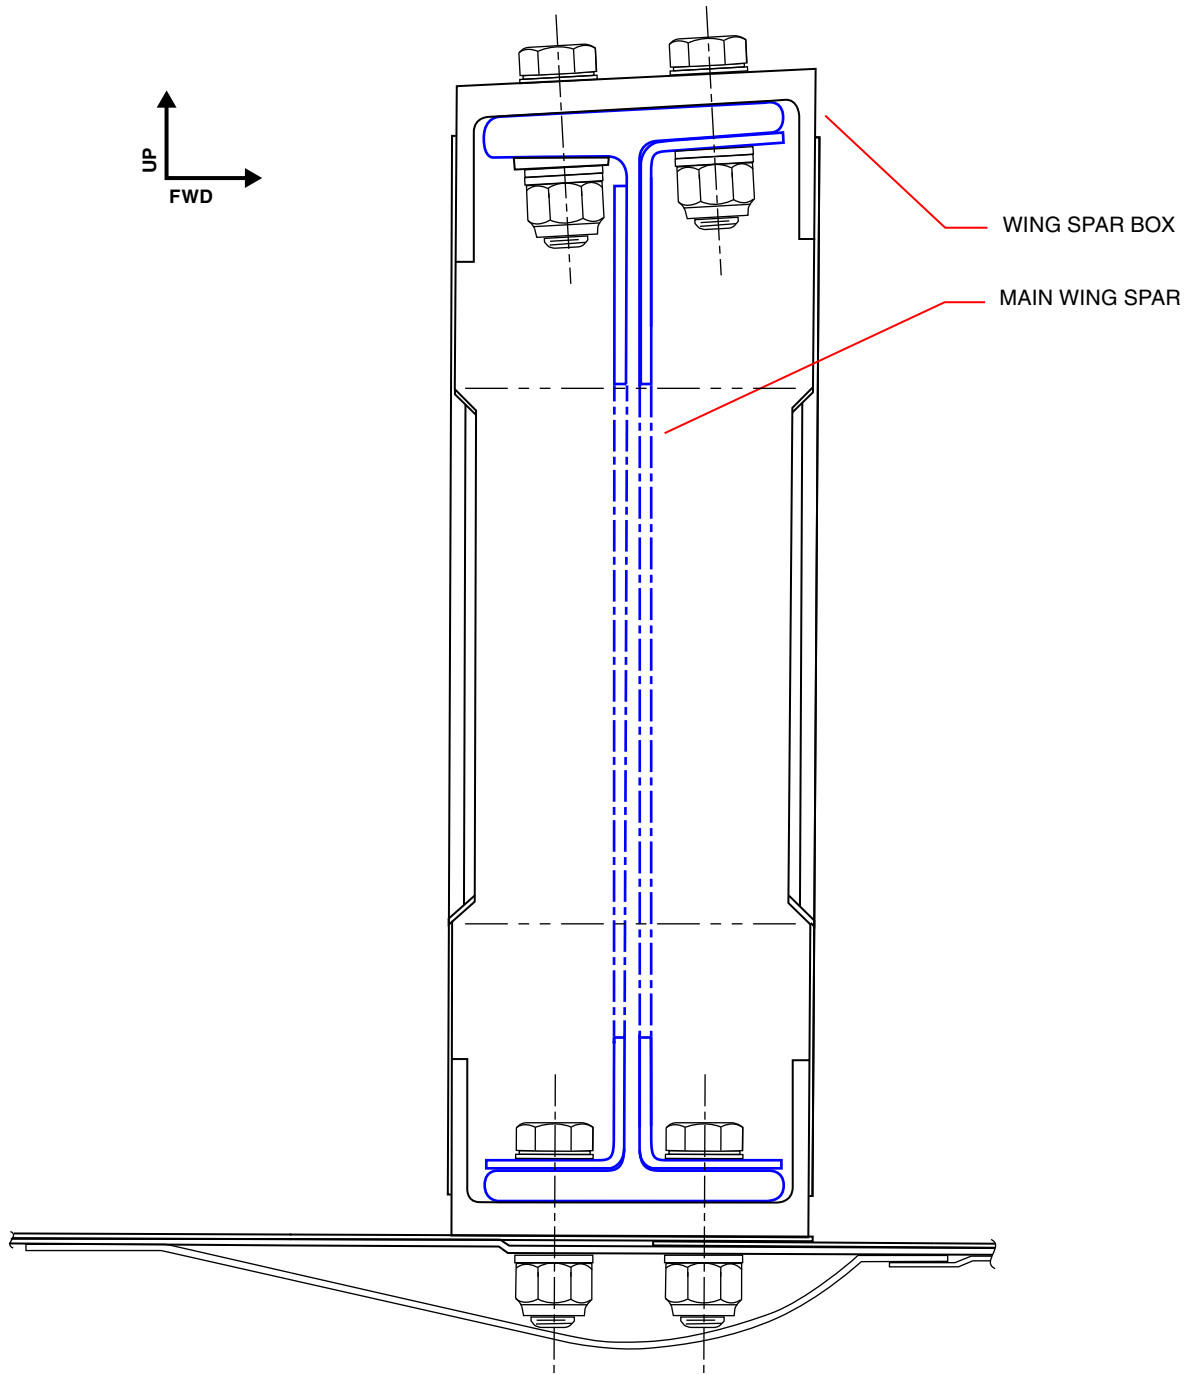
**Figure 1, Sheet 2 of 2**

**VIEW C-C**

WING SPAR CROSS SECTION  
SHOWN AS INSTALLED IN WING SPAR BOX
