Piper Aircraft, Inc.  
2926 Piper Drive  
Vero Beach, FL, U.S.A. 32960

# SERVICE BULLETIN

NO. 1372

### MAIN WING SPAR INSPECTION

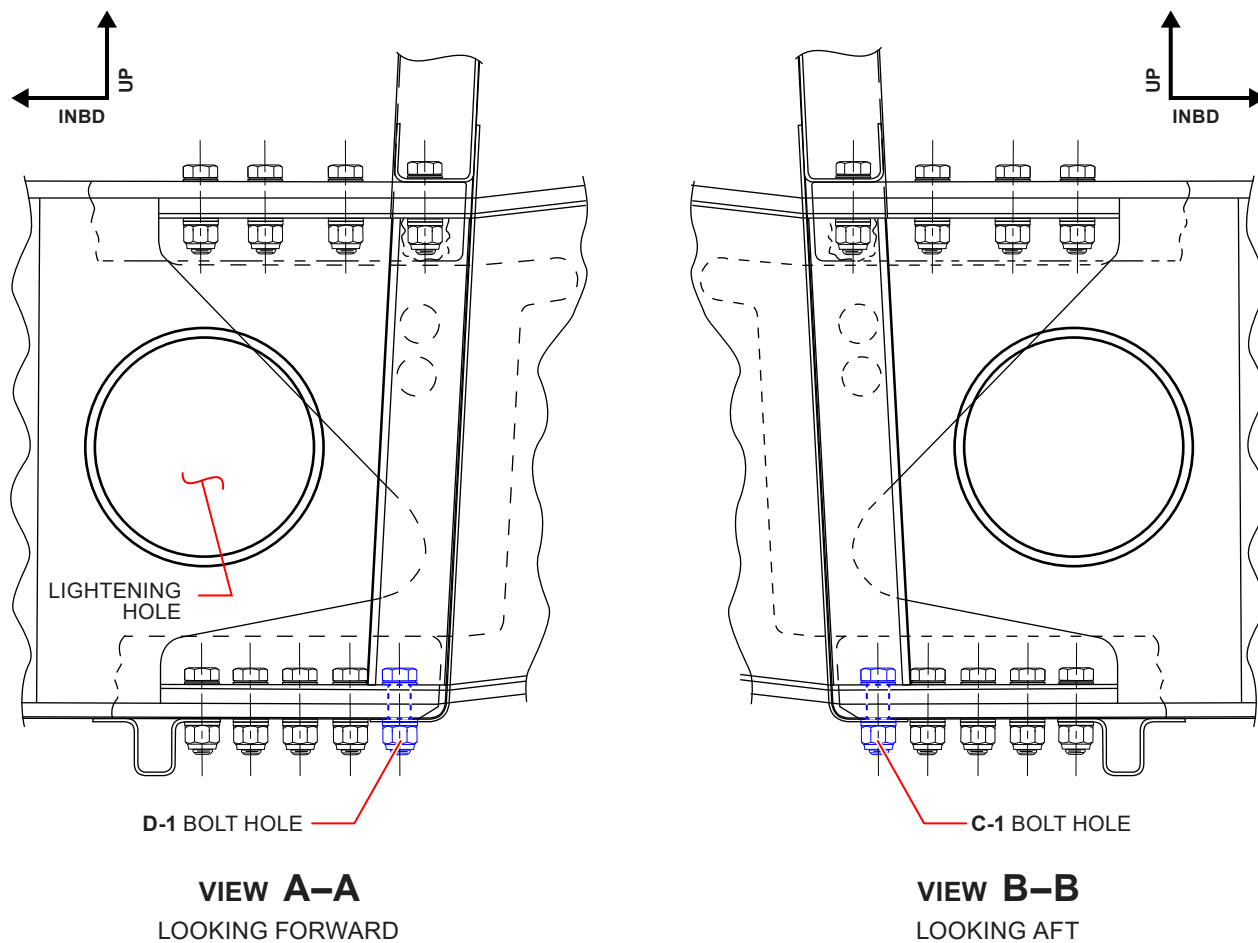
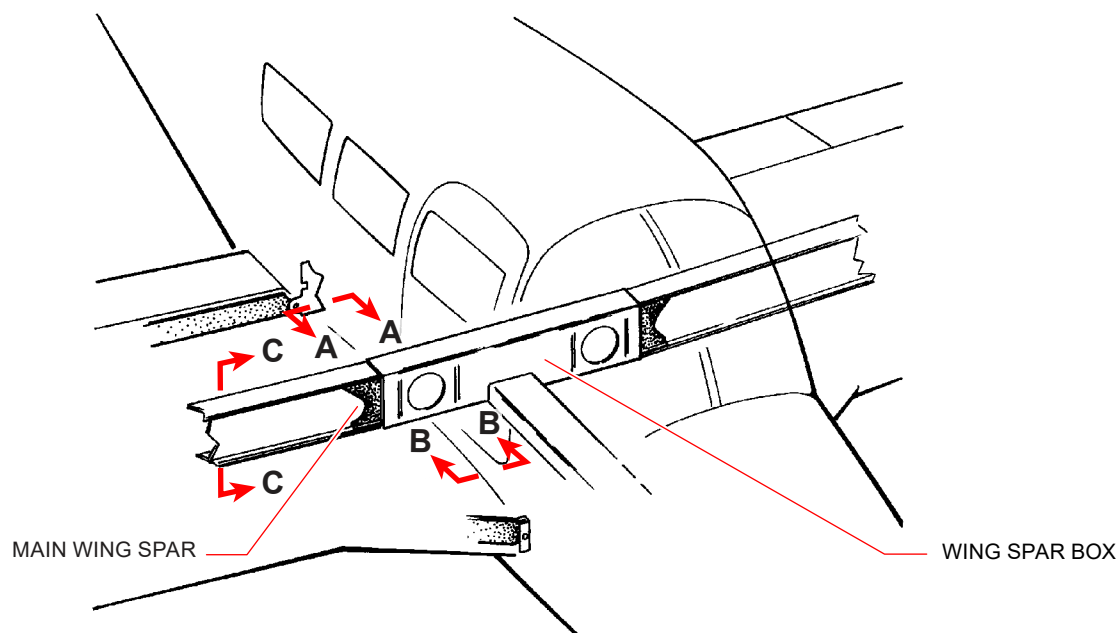
**Figure 1** (Sheet 1 of 2)  
Typical Main Wing Spar Attach Bolts and Spar Cross Section (Right Wing Shown)

Depending on the severity of usage, some of the affected aircraft may have fatigue fractures at the lower outboard-most wing attachment holes (designated as C-1 and D-1 as shown in Figure 1 on page 16).

**WARNING:** Do not drive bolts into or out of the main spar attaching bolt holes (see Views A-A and B-B). Be careful to avoid damaging the bolt holes while removing and replacing the bolts. Refer to "Care for Bolts and Bolt Holes" in this service bulletin.

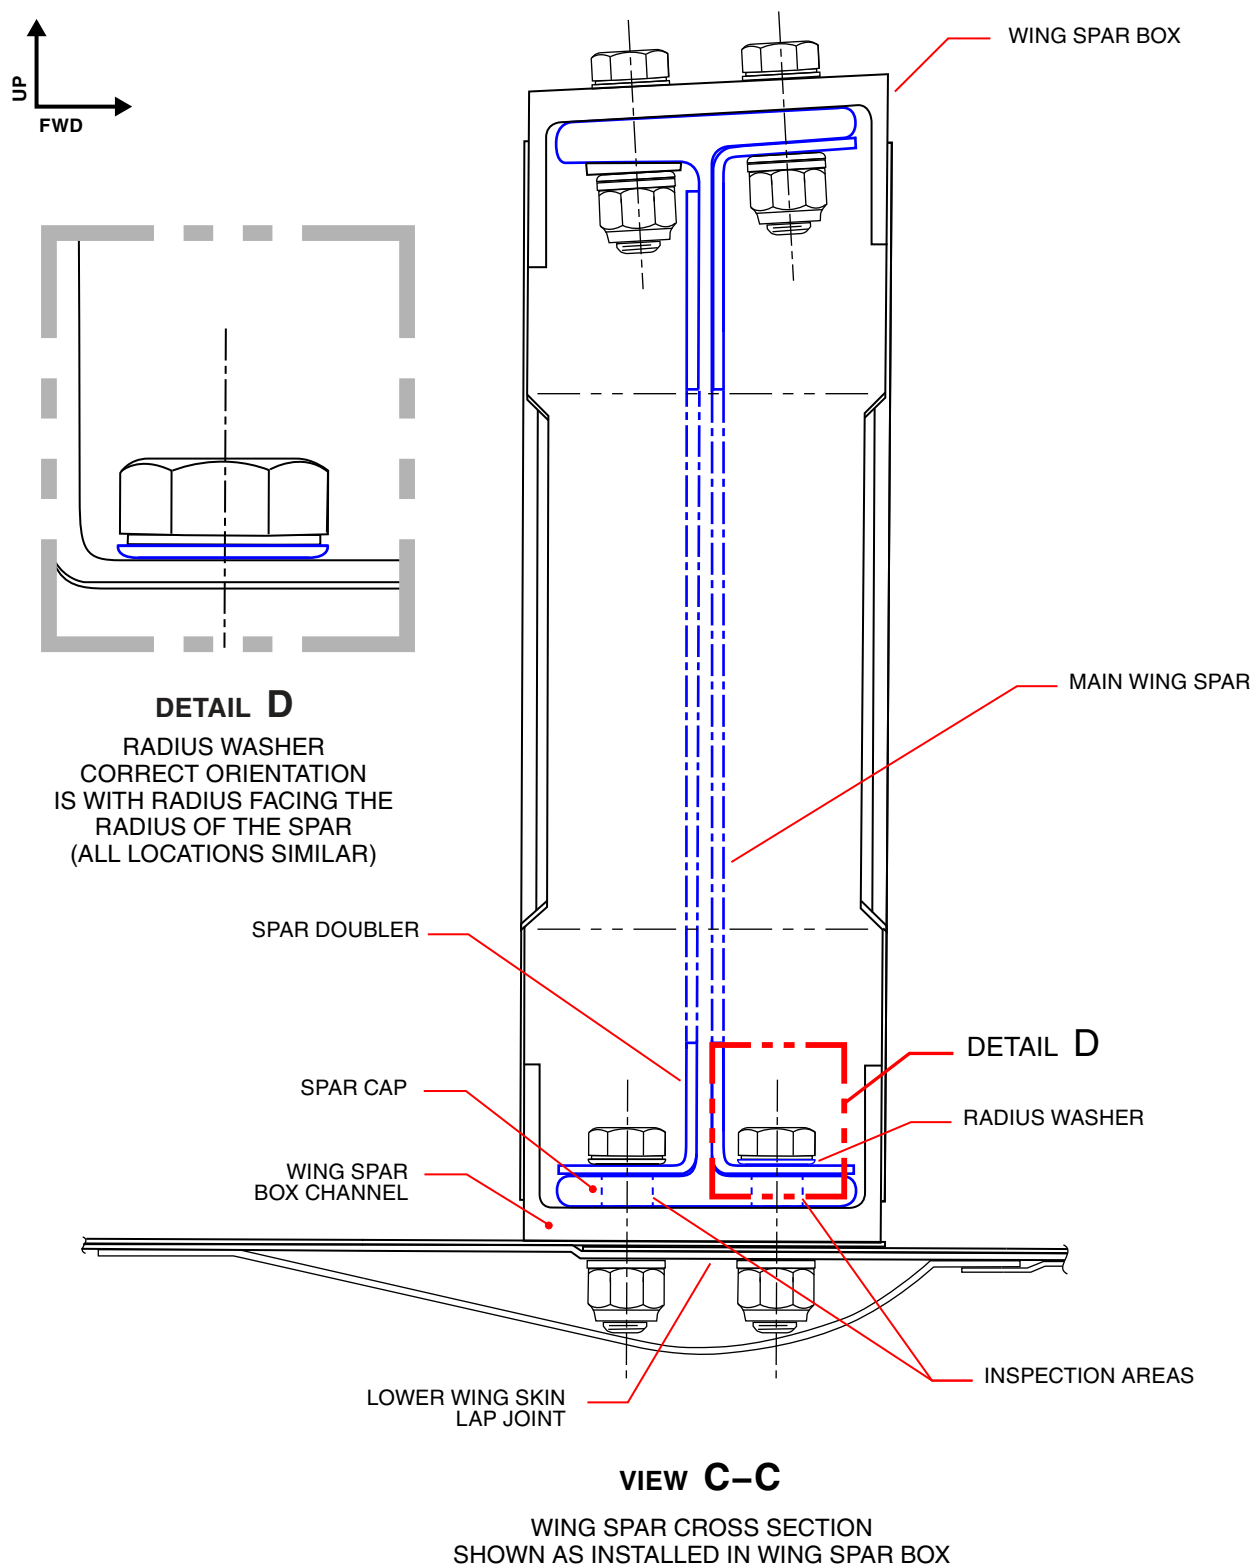
**Figure 1** (Sheet 2 of 2)  
Typical Main Wing Spar Attach Bolts and Spar Cross Section (Right Wing Shown)

The subject bolt holes, as viewed from beneath the wing, penetrate the aluminum sheets in the lower skin lap joint, the lower surface of the wing spar box, the lower flanges of the spar extrusions, and the web doublers on the upper surface of the lower spar flange. The pass-fail criteria of this inspection is only applicable to a crack in the spar extrusion. Damage in the other areas mentioned should be reported to Piper Aircraft, Inc. for disposition.
