Piper Aircraft, Inc.  
2926 Piper Drive  
Vero Beach, FL, U.S.A. 32960

# SERVICE NO. 1375C BULLETIN

Date: May 12, 2023

**PERIODIC REPLACEMENT OF MAIN LANDING  
GEAR ATTACHMENT HARDWARE**

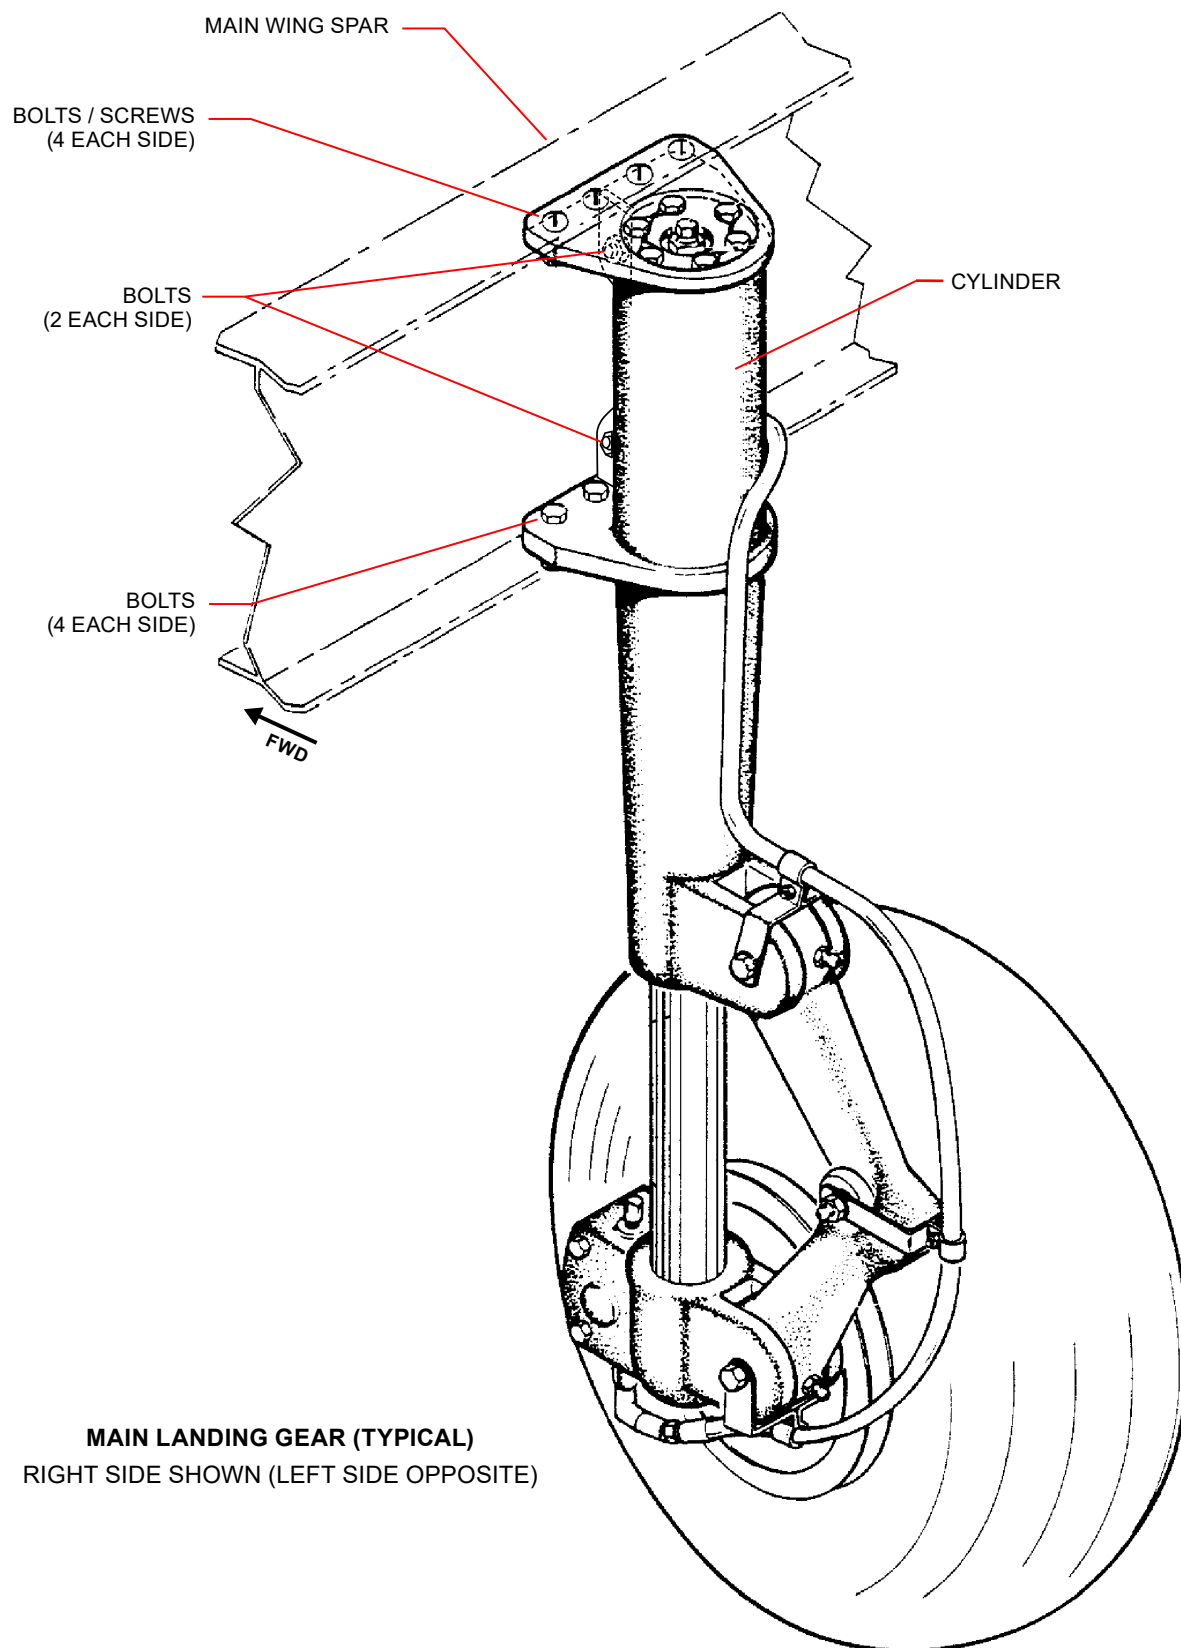
**Figure 1**  
Main Landing Gear – Mounting Hardware

A review of service history reveals that for the affected aircraft, the landing gear mounting hardware is subject to metal fatigue, hole wear and corrosion. Failure of this hardware could result in a landing gear collapse. Hole wear may cause fretting fatigue cracking.

The main landing gear (MLG) is attached to the aircraft with threaded fasteners that pass through mounting flanges on the strut cylinder and the upper and lower flanges of the main wing spar, as depicted in the illustration below. On some of the affected aircraft, additional threaded fasteners pass through the web of the main wing spar.

1. Place the aircraft on jacks.
2. Remove the fairing from around the strut cylinder housing and the access plate located on the bottom of the wing and to the rear of the housing by removing attaching screws.
3. Remove the MLG and discard all of the threaded fastener stack ups (which includes screws, bolts, nuts, and washers) that attach the MLG to the main wing spar. (See Figure 1.)
4. Bolt Hole Inspection
