# SERVICE NO. 1156D BULLETIN

Date: August 3, 2026

**PERIODIC INSPECTION AND REPLACEMENT OF  
NOSE GEAR DRAG LINK BOLT**

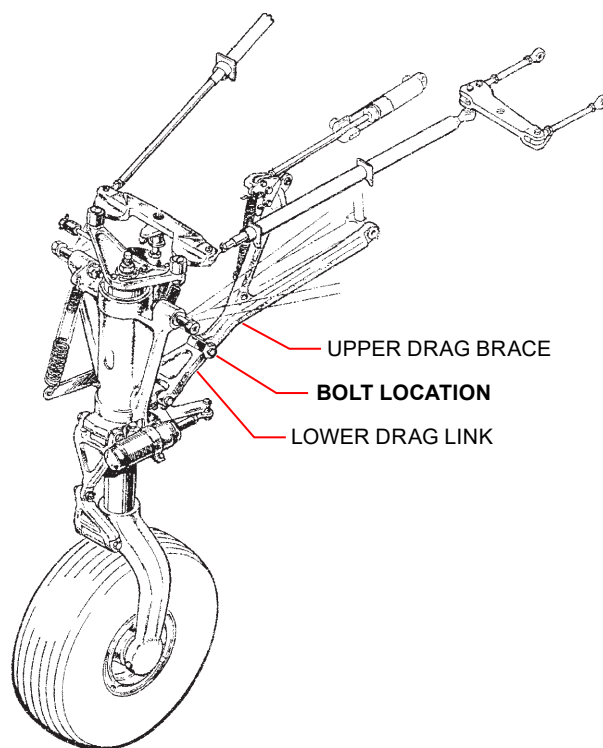
Figure 1  
Typical PA-28R/28RT Bolt Location

The bolt that fastens the upper and lower nose gear (NG) drag links can develop wear in a manner that may not be detectable during routine maintenance and inspection. Specifically, on some aircraft, score marks have been discovered around the circumference of the bolt shank, midway along the length of the bolt.

By design, the bolt is free to rotate inside a set of bearings to allow relative movement between the upper and lower drag links during landing gear extension and retraction. Over an extended number of operating hours, this rotation can generate the score marks described, causing stress concentrations to develop in the bolt.

Left uncorrected, this condition could eventually result in bolt failure, with subsequent nose gear collapse.

1. Jack the aircraft per the applicable Piper AMM or SM.
2. Disassemble the upper drag brace from the lower drag link by removing the NAS464P4-27 bolt that functions as a hinge pin for the two parts. See Figure 1 or Figure 2, as applicable. Discard the cotter pin, regardless of condition. The castellated nut, washers and bearings may be reused, depending on condition.

- If the TIS of the bolt is less than 500 hours: clean and inspect the bolt for damage (especially for score marks around the circumference of the bolt shank, midway along the bolt's length). If the bolt is serviceable, then reinstall it; otherwise replace on condition.

- If the TIS of the bolt is 500 or more hours: replace it with a new NAS464P4-27 bolt, regardless of condition.
3. Before installing the bolt, inspect the bearings for excessive wear and verify the inner diameter of the bearings are within the range of 0.2495–0.2515 inches. Replace bearings (Piper P/N 452-800) on condition.

If new bearings are installed, perform a final reaming operation, on the upper drag brace only, to achieve an inner diameter of 0.2495–0.2505 inches through both bearings.

**NOTE:** The nose gear drag link assembly is comprised of two major components: the upper drag brace and the lower drag link. The line ream operation described above applies only to the upper drag brace, and does not apply to the lower drag link. See Figure 1 or Figure 2, as applicable.
