Piper Aircraft, Inc.  
2926 Piper Drive  
Vero Beach, FL, U.S.A. 32960

# SERVICE NO. 1140B BULLETIN

**OXYGEN GENERATOR PROTECTIVE CAP AND  
TUBE REMOVAL**

PA-46-310P Malibu  
PA-46-350P Mirage / M350  
PA-46-500TP Meridian / M500  
PA-46-600TP M600  
PA-46-701TP M700 Fury

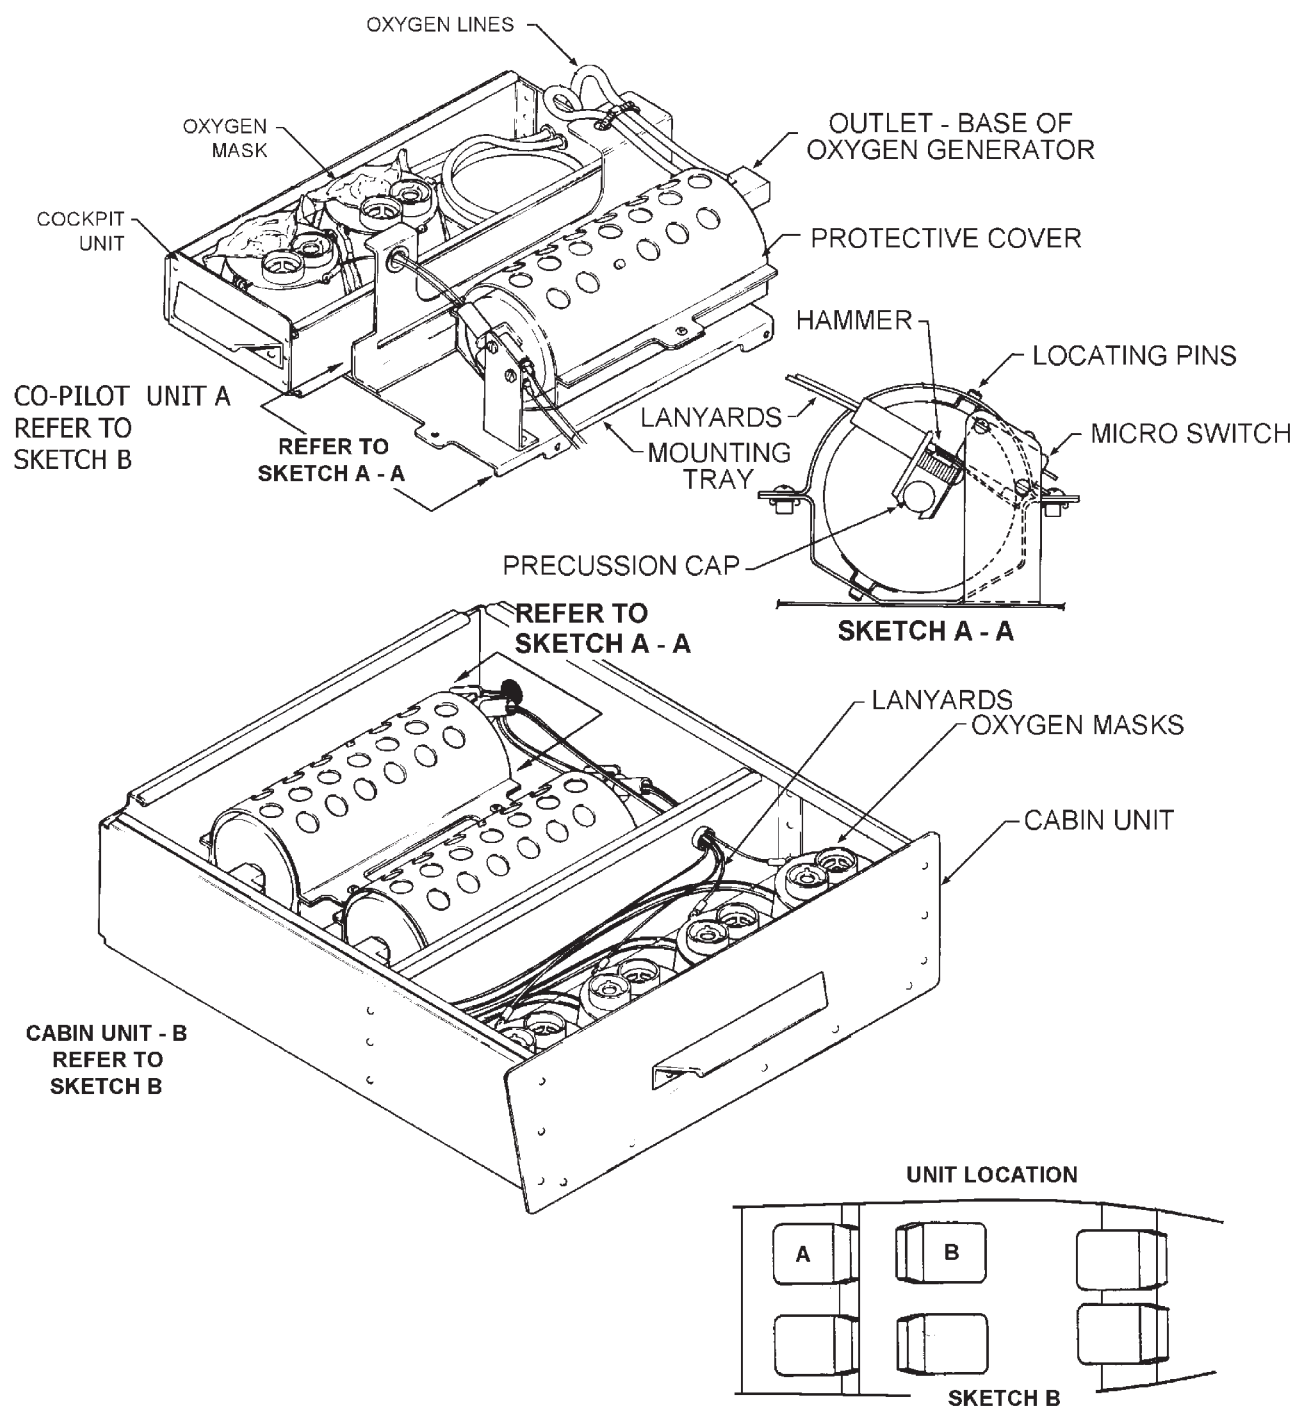
**Figure 1** (Sheet 1 of 2)  
Oxygen System Installation

1. Locate the oxygen generators, Piper P/N's 471-025 or 557-805, underneath the co-pilot's seat and the RH, aft facing, rear seat. See Figure 1.

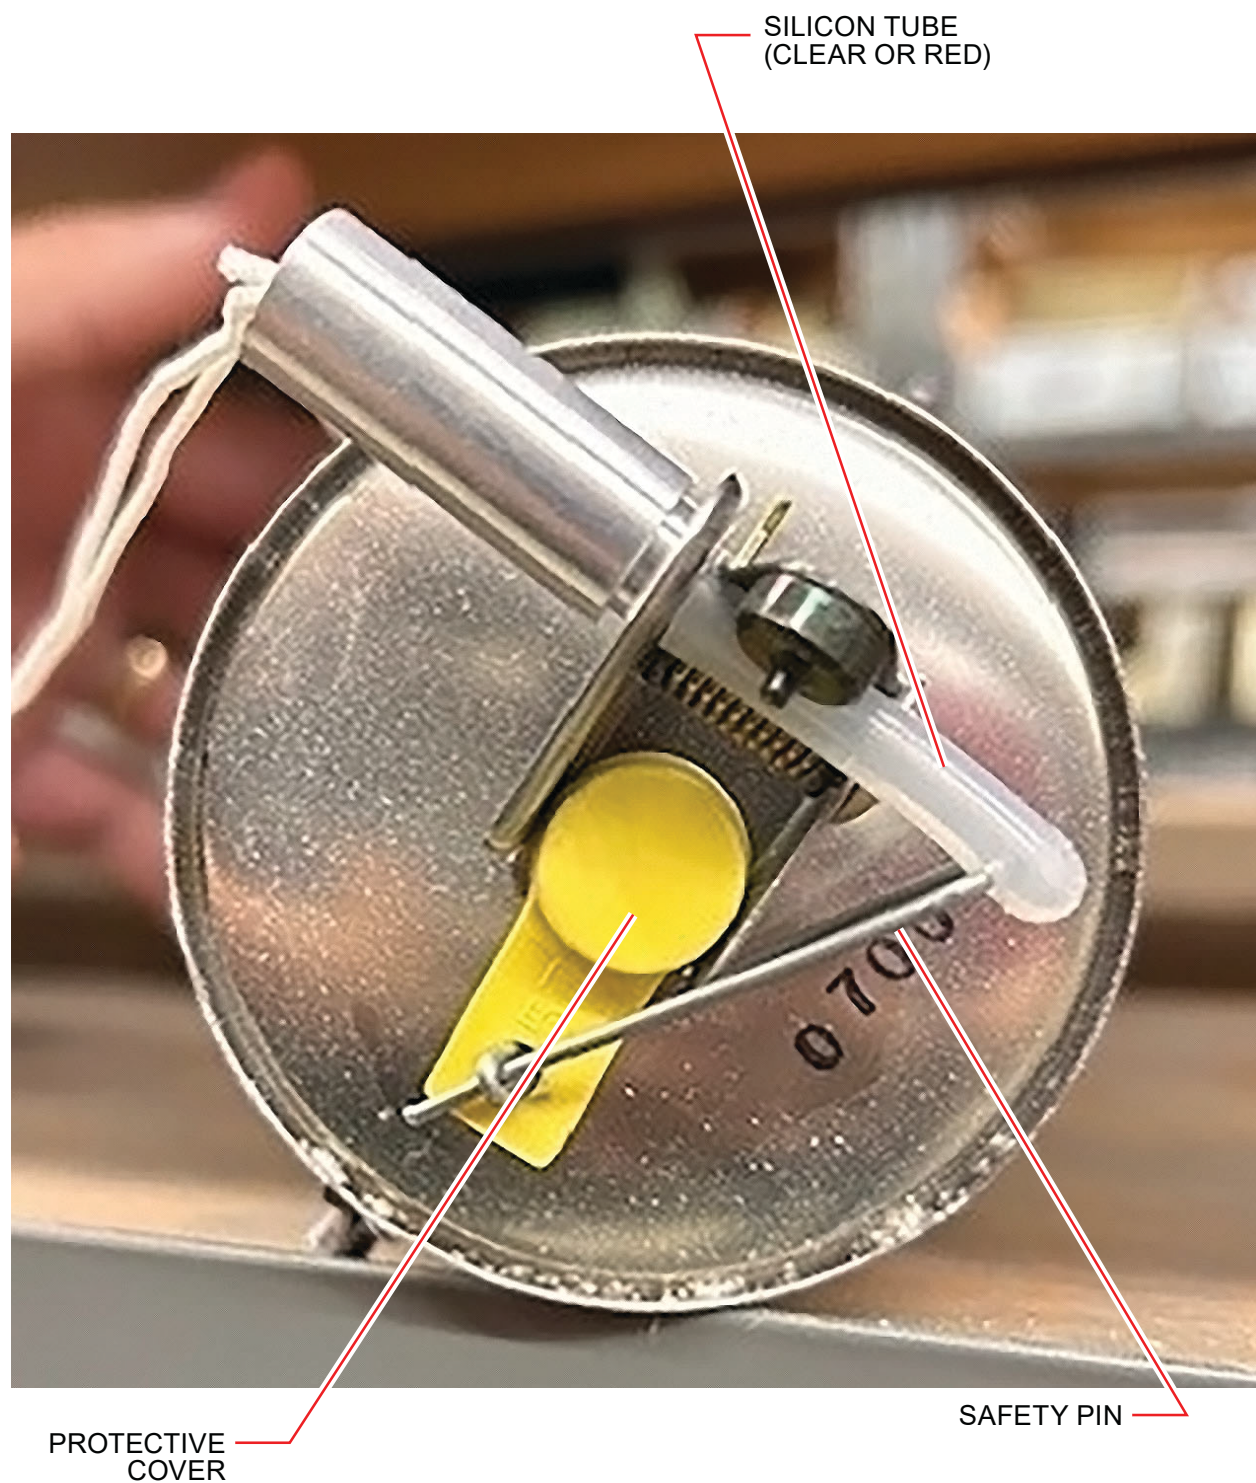
**Figure 2**  
Oxygen Generator Safety Equipment Installation

It has been discovered that the affected aircraft may have been equipped with emergency oxygen generators with the protective shipping cover and/or a silicon safety tube not removed. The oxygen generators are activated by a trigger mechanism that strikes a percussion cap located on the end of the generator. Failure to remove the protective cover from the percussion cap and/or the silicon tube will result in the trigger mechanism not making contact with the percussion cap and, consequently, no activation of the oxygen generator.

2. Examine the end of each oxygen generator where the percussion cap is located, see Figures 1 and 2, for presence of a yellow colored, protective cover and/or a silicon tube installed over the end of the trigger mechanism pin. If no protective covers or silicone tubes are found in the area shown in Figure 2, no further action is required, proceed to Step 4.

**NOTE:** Silicon tubes may be either red or clear and thus difficult to see. Take care to ensure all silicon tubes are removed.

3. If the yellow protective covers are found on any of the oxygen generator percussion caps, they must be removed. In addition, a silicon tube may also be installed over the end of the trigger mechanism pin, this tube may be secured to the protective cover by a safety pin. These components must also be removed. Remove protective covers, silicon tubes, and safety pins, see Figure 2, as follows:

**CAUTION:** WHEN REMOVING PROTECTIVE COVERS AND/OR SILICON TUBES, ENSURE ALL THREE COMPONENTS SHOWN IN FIGURE 2 ARE REMOVED, AS REQUIRED.

- a. Remove the yellow colored protective cover from the percussion cap.
  - b. If the silicon tube is installed, grasp it with needle nose pliers and pull to remove the tube and protective cover from the oxygen generator.
4. Make a logbook entry documenting compliance with this service bulletin.
