# SERVICE NO. 1429A BULLETIN

Date: October 13, 2026

**TRIM CABLE PULLEY RELOCATION**

| DWG TITLE<br>REWORK - PULLEY MOUNTING BRACKET ASSY RELOCATION | | | | DWG NO<br>88762 | REV<br>A | SH<br>1 OF 5 |

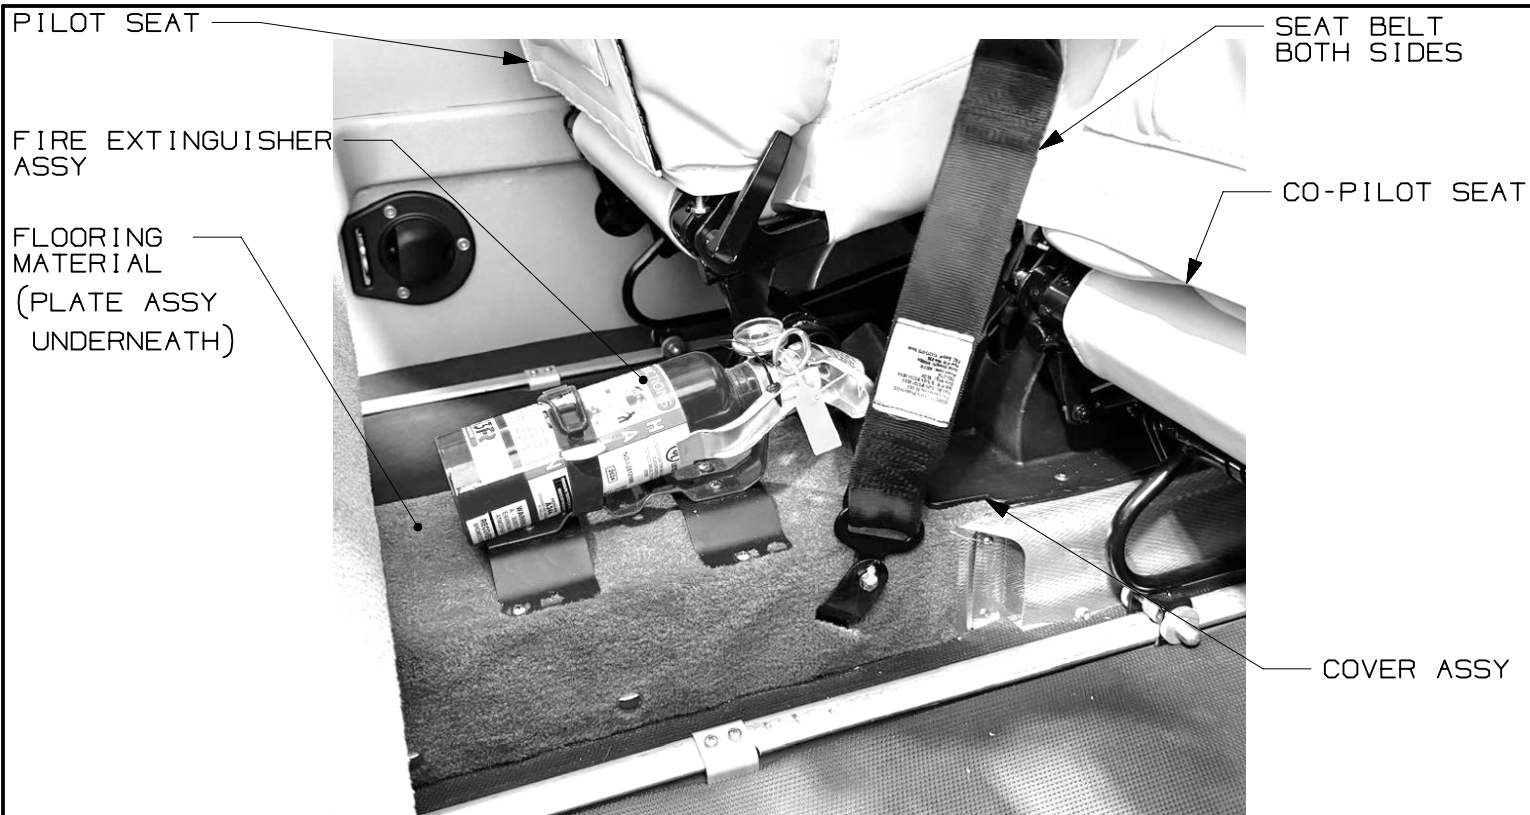
FIGURE 1. EQUIPMENT/FURNISHINGS PARTS TO BE REMOVE AND RE-INSTALL

1. REMOVE THE PILOT, CO-PILOT SEATS, AND FORWARD CENTER SEAT BELT. (A)  
(REFERENCE FIG. 1)
2. REMOVE THE FOLLOWING ASSYS AND HARDWARE TO GAIN ACCESS TO THE PULLEY MOUNTING BRACKET; (A)  
FIRE EXTINGUISHER ASSY (82235-002)  
COVER ASSY (28F250045-003 - ARCHER, 67785-017 - PILOT)  
FLOORING MATERIAL, CARPET ASSY (76160-007 - ARCHER)  
OR  
COVER ASSY (28F25V001-032 - PILOT)  
PLATE ASSY (76121-000)  
(REFERENCE FIG. 1)

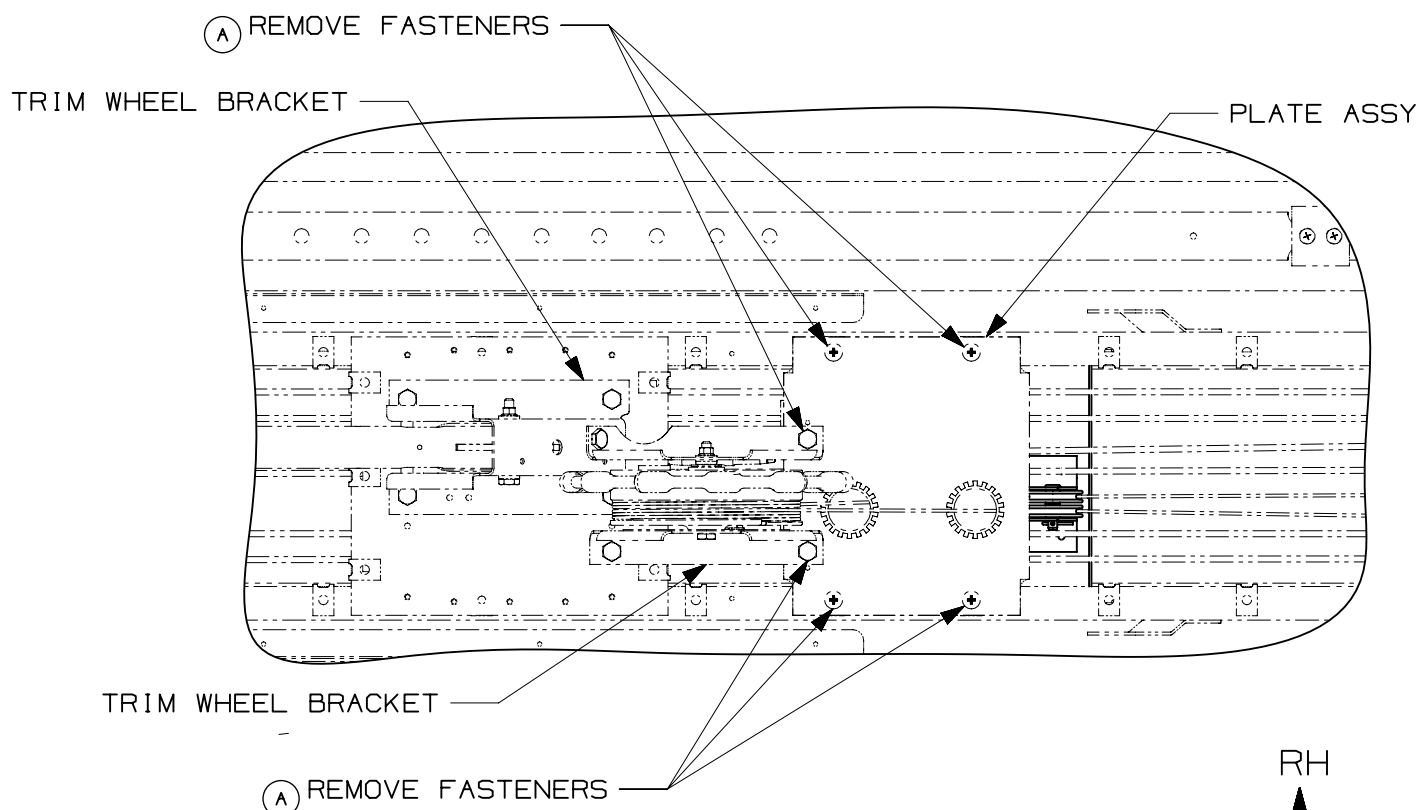
FIGURE 2. STABILATOR TRIM PARTS TO BE REMOVED AND RE-INSTALLED (A)  
SCALE 1:4

3. REMOVE FASTENERS THAT HOLD PLATE ASSY (28F270001-003) TO TUNNEL ASSY (A)  
(28F53A185-001) AND TRIM WHEEL BRACKETS (65633-000 AND 65635-000).  
(REFERENCE FIG. 2)
