# SERVICE NO. 1449 BULLETIN

**ALTERNATE AIR CABLE CHAFE INSPECTION  
AND MODIFICATION**

PA-44-180 Seminole  
equipped with Fuel Injected Engines

4496404 thru 4496649

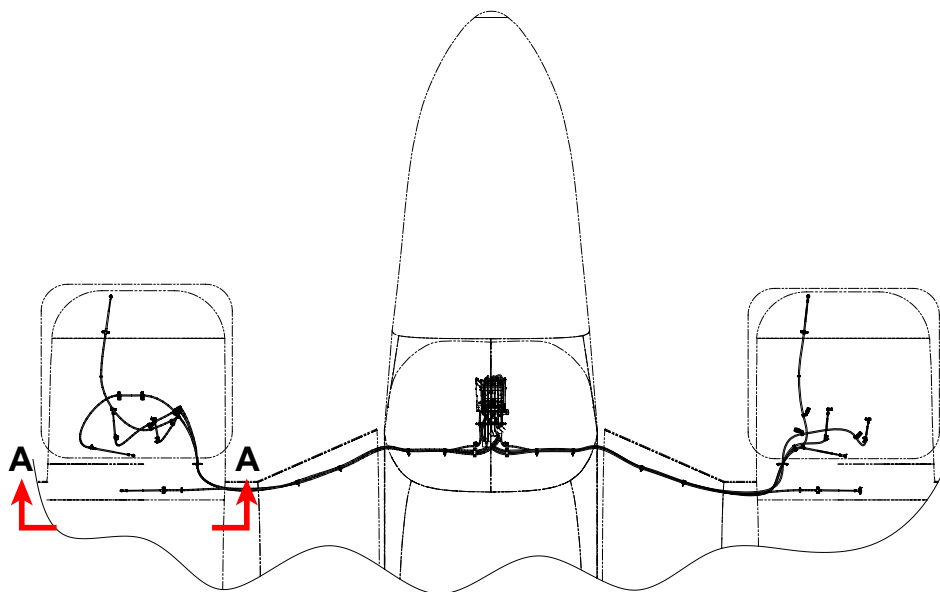
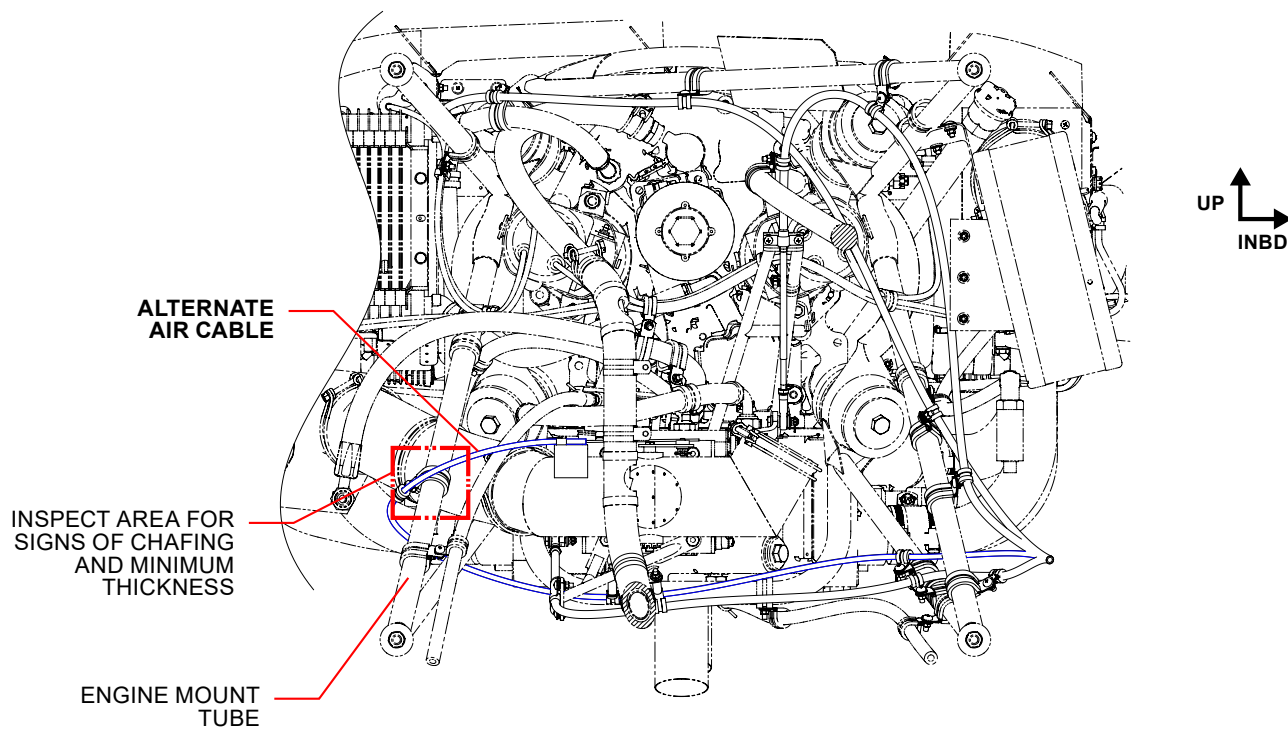
Figure 1  
Alternate Air Cable Inspection Location

In some affected aircraft equipped with fuel injected engines, the LH engine alternate air cable attach clamp may have rotated, allowing for the cable to chafe against the engine mount tube, leading to a certain loss of material from the engine mount tube over time. This service bulletin mandates a one-time inspection, and on condition, repair or replacement of the engine mount. In addition, this document mandates a one-time modification of the alternate air cable installation to reduce chafing damage, regardless of whether the engine mount was repaired or replaced.

1. Locate the LH engine alternate air cable, as shown in Figure 1.
2. Remove screw, clamps, washer, and nut securing alternate air cable to the engine mount.

3. Inspect area of engine mount near alternate air cable installation for signs of chafing damage.
  - If chafing damage is found, further inspection is required. Proceed to step 4.

- If no chafing damage is found, no further inspection is required. Proceed to step 5.
4. If chafing damage is found, perform an Ultrasonic Thickness Inspection on the affected area of the engine mount to verify a minimum thickness of 0.0441 inches without primer:
