# SERVICE NO. 1462 BULLETIN

### **RUDDER CABLE INSPECTION**

PA-46-350P M350  
PA-46-500TP M500  
PA-46-600TP M600  
PA-46-701TP M700 Fury

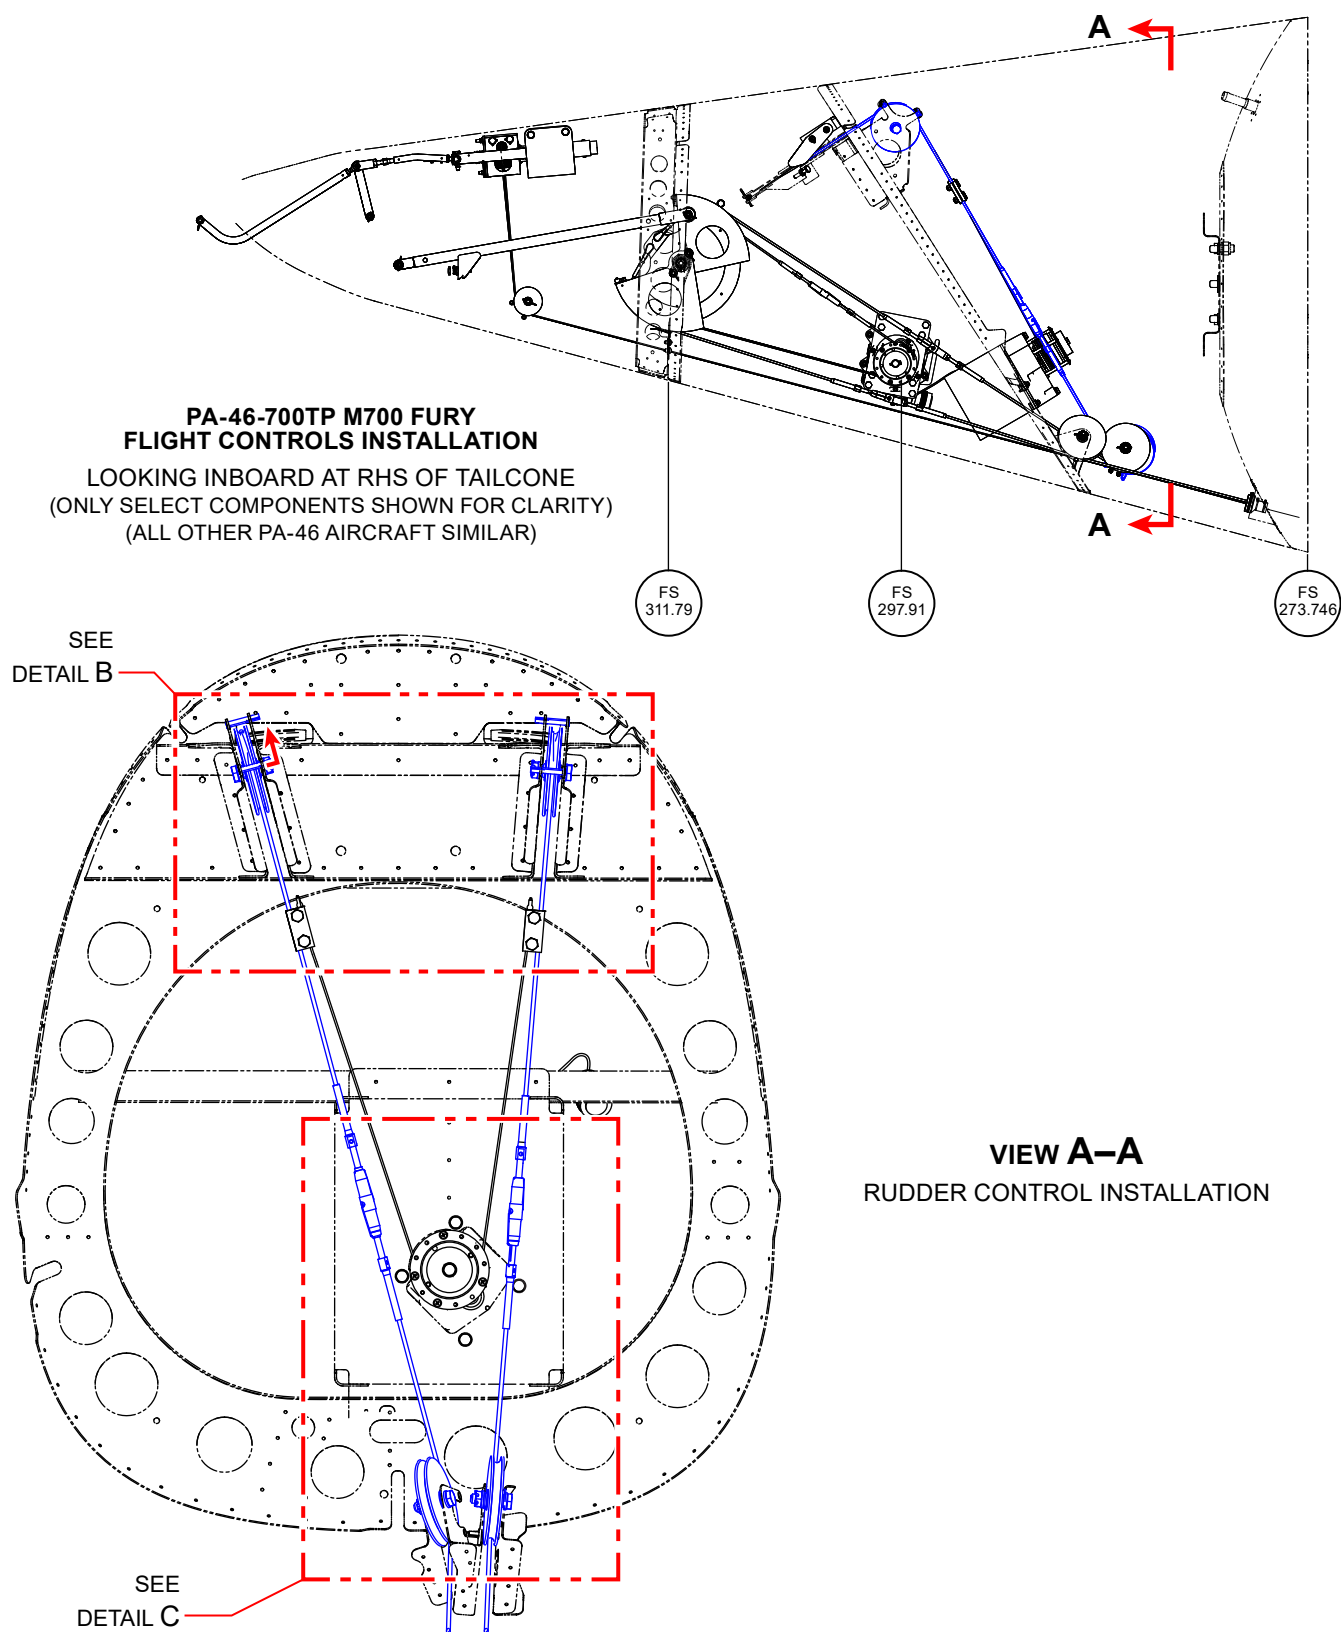
Figure 2 (Sheet 1 of 2)  
Rudder Control Cable & Pulley Inspection  
(PA-46-700TP Shown, All Other PA-46 Aircraft Similar)

Some of the affected aircraft may have rudder drive (i.e. control) cables incorrectly routed in the tailcone. Left uncorrected will cause chafing damage and/or breakage. This service bulletin mandates a one-time inspection of the rudder controls within the tailcone and, on condition, contact Piper Customer Support for further information.

3. Inspect the rudder cables, pulleys, cables guards (pins), and the surrounding structure. Determine if the cables are routed correctly through the pulleys and cable guards (pins) as shown in Detail B & Detail C of Figure 2. If rudder cables are incorrectly routed, inspect the cables, pulleys, pins, pulley brackets, and nearby structure for damage and wear according to "Control Cable Inspection" in 27-00-00 of the applicable Airplane Maintenance Manual (AMM).
  - If the cables are properly routed and no damage is discovered, proceed to step 4.
  - If the cables are incorrectly routed and damage is discovered, contact Piper Customer Support for further information.
4. If the cables are properly routed and no damage is discovered, reinstall the access panel onto the tailcone.
5. Make a logbook entry documenting compliance with this service bulletin.

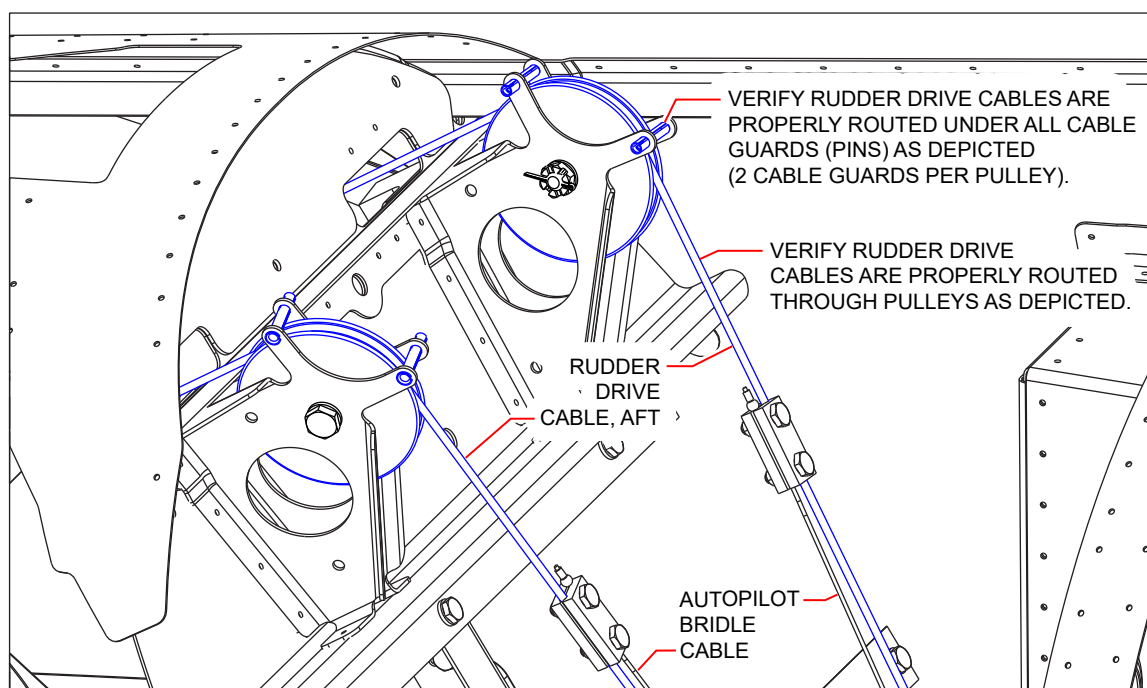
**DETAIL B**

UPPER RUDDER CABLE PULLEYS  
SKIN AND OTHER COMPONENTS REMOVED FOR CLARITY

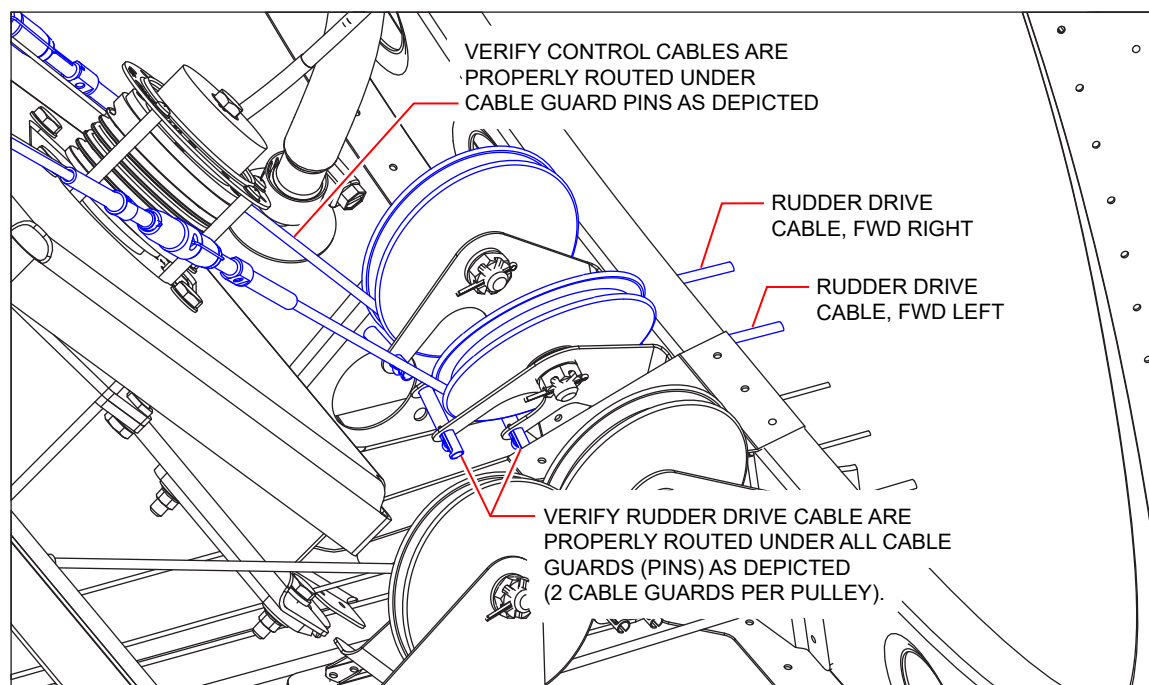
**DETAIL C**

LOWER RUDDER CABLE PULLEYS  
SKIN AND OTHER COMPONENTS REMOVED FOR CLARITY
