# SERVICE NO. 1360 LETTER

**PRECOOLER BRACKET INSPECTION**

PA-46-500TP M500  
PA-46-600TP M600  
PA-46-701TP M700 Fury

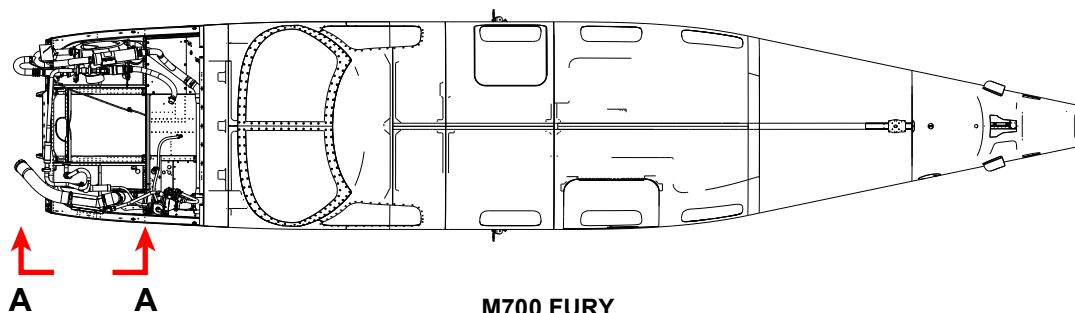
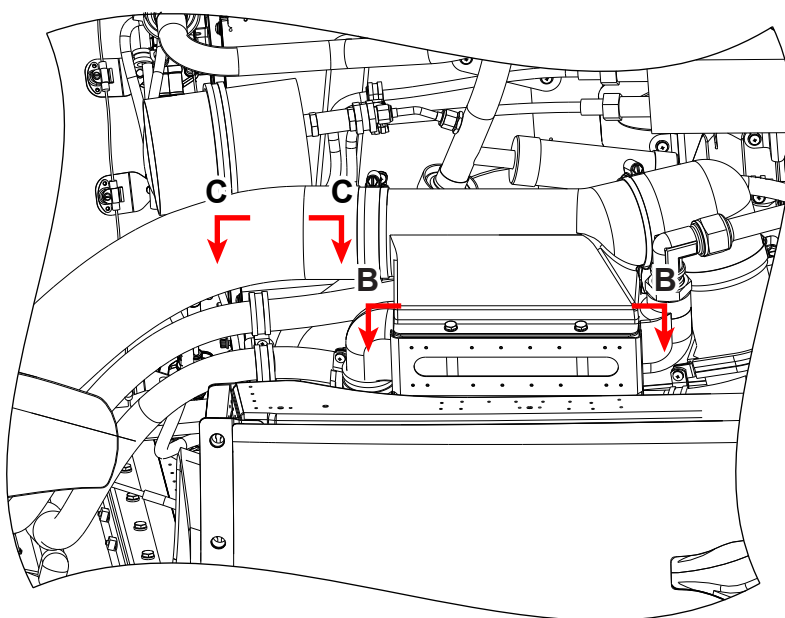
Figure 1 (Sheet 1 of 2)  
 Pre-cooler Bracket Inspection Locations

Some precooler mounting brackets may have been formed backwards. Left uncorrected this may result in chafing between the forward end of the mounting bracket and the longeron assembly as well as between the oil cooler hose support spacer and the bleed air tube assembly. This service letter provides instructions for inspecting these locations to ensure clearance and lack of chafing, as well as instructions to replace the precooler bracket on condition.

3. Inspect between forward end of pre-cooler bracket and longeron assembly and between oil cooler hose support spacer and bleed air tube assembly for signs of chafing and ensure clearance to adjacent structure.
