SERVICE BULLETIN

Service Bulletin No. 671B
(Supersedes Service Bulletin No. 671A)
Engineering Aspects are FAA Approved

SUBJECT: Fuel Pump Leak Inspection and Diaphragm Replacement, Hartzell Engine Tech (HET) Alert Service Bulletin No.233

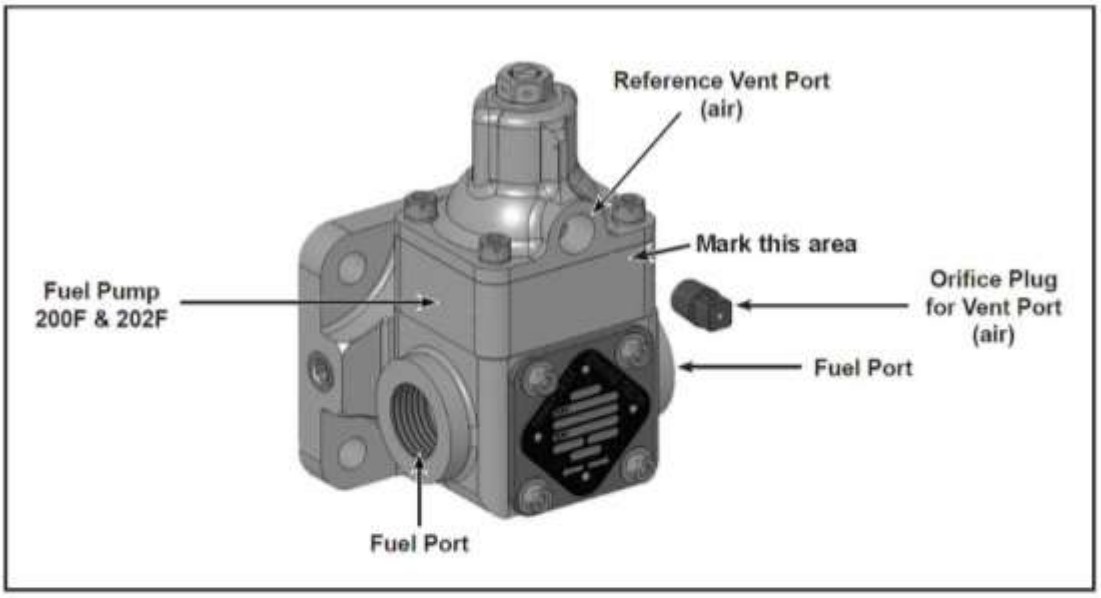
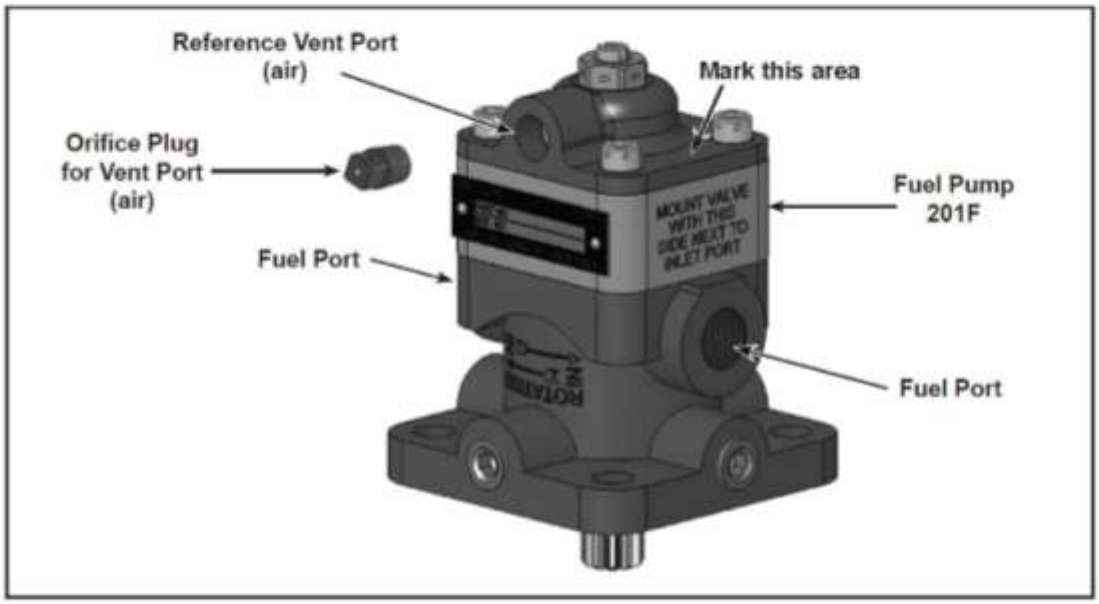
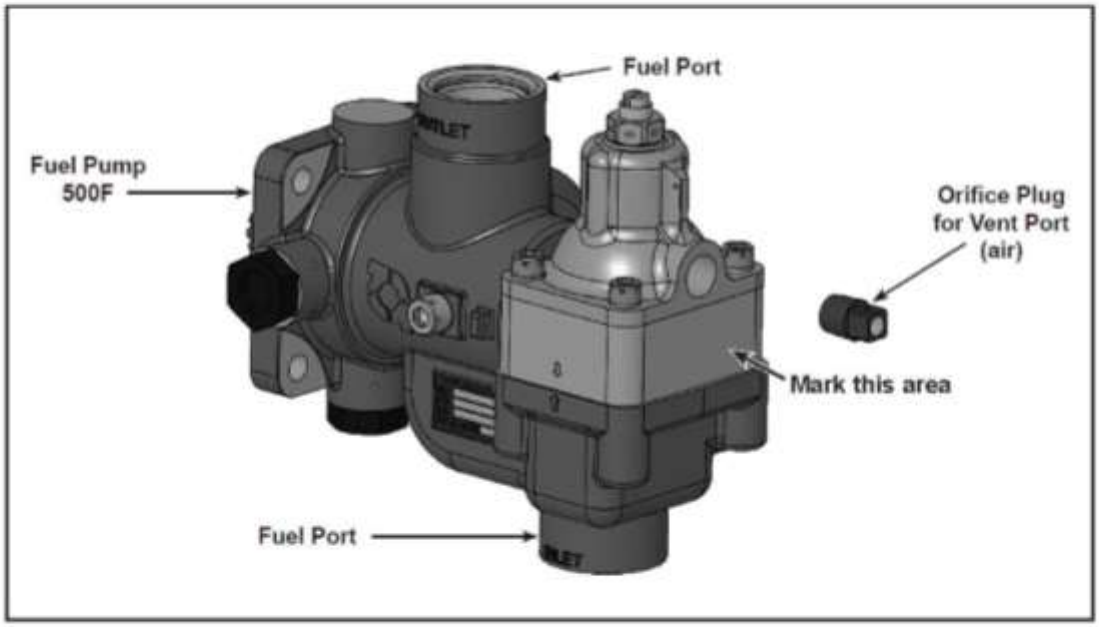
(a) Inspect the vent reference port and surrounding area on the exterior of affected fuel pumps for indications of fuel leakage, such as staining or wetting of the port. See Figures 1 thru 3.

1) For Aviation Gasoline power engines staining will be blue in color.

2) For kerosene powered engines, leakage will show as an oily film or pools in low areas.

(a) Inspection of the orifice plug requires only a visual inspection. Look around the plug and into the orifice for fuel or blue dye stains. Refer to Fig. 1, Fig. 2, or Fig. 3.

(h) Mark field repaired pumps with a green dot on the valve housing front face (200F, 202F, and 500F) or top of valve housing cover (201F) using an indelible paint marker. Dot size to be 1/8 inch to 1/4 in diameter and must not overlap or obscure any existing markings. See Figures 1 through 3.

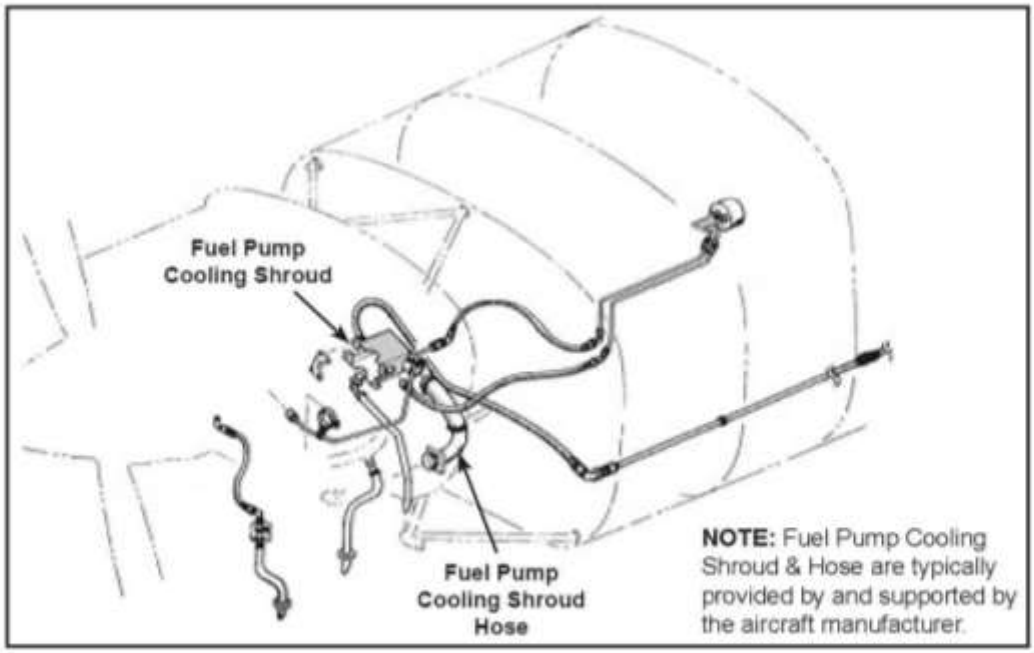
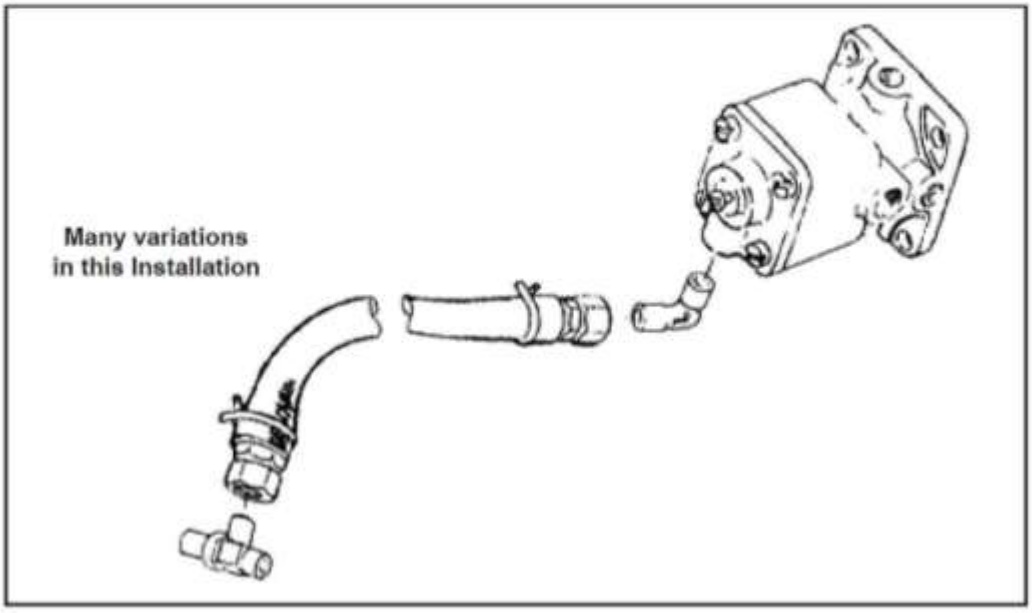
(b) Inspection of the upper deck reference line requires that the line be disconnected and the inside of the fitting be inspected for fuel or blue dye stains. Refer to Fig. 5 and 6.
