Piper Aircraft, Inc.  
2926 Piper Drive  
Vero Beach, FL, U.S.A. 32960

# SERVICE NO. 1345A BULLETIN

Date: September 17, 2021

### MAIN WING SPAR INSPECTION

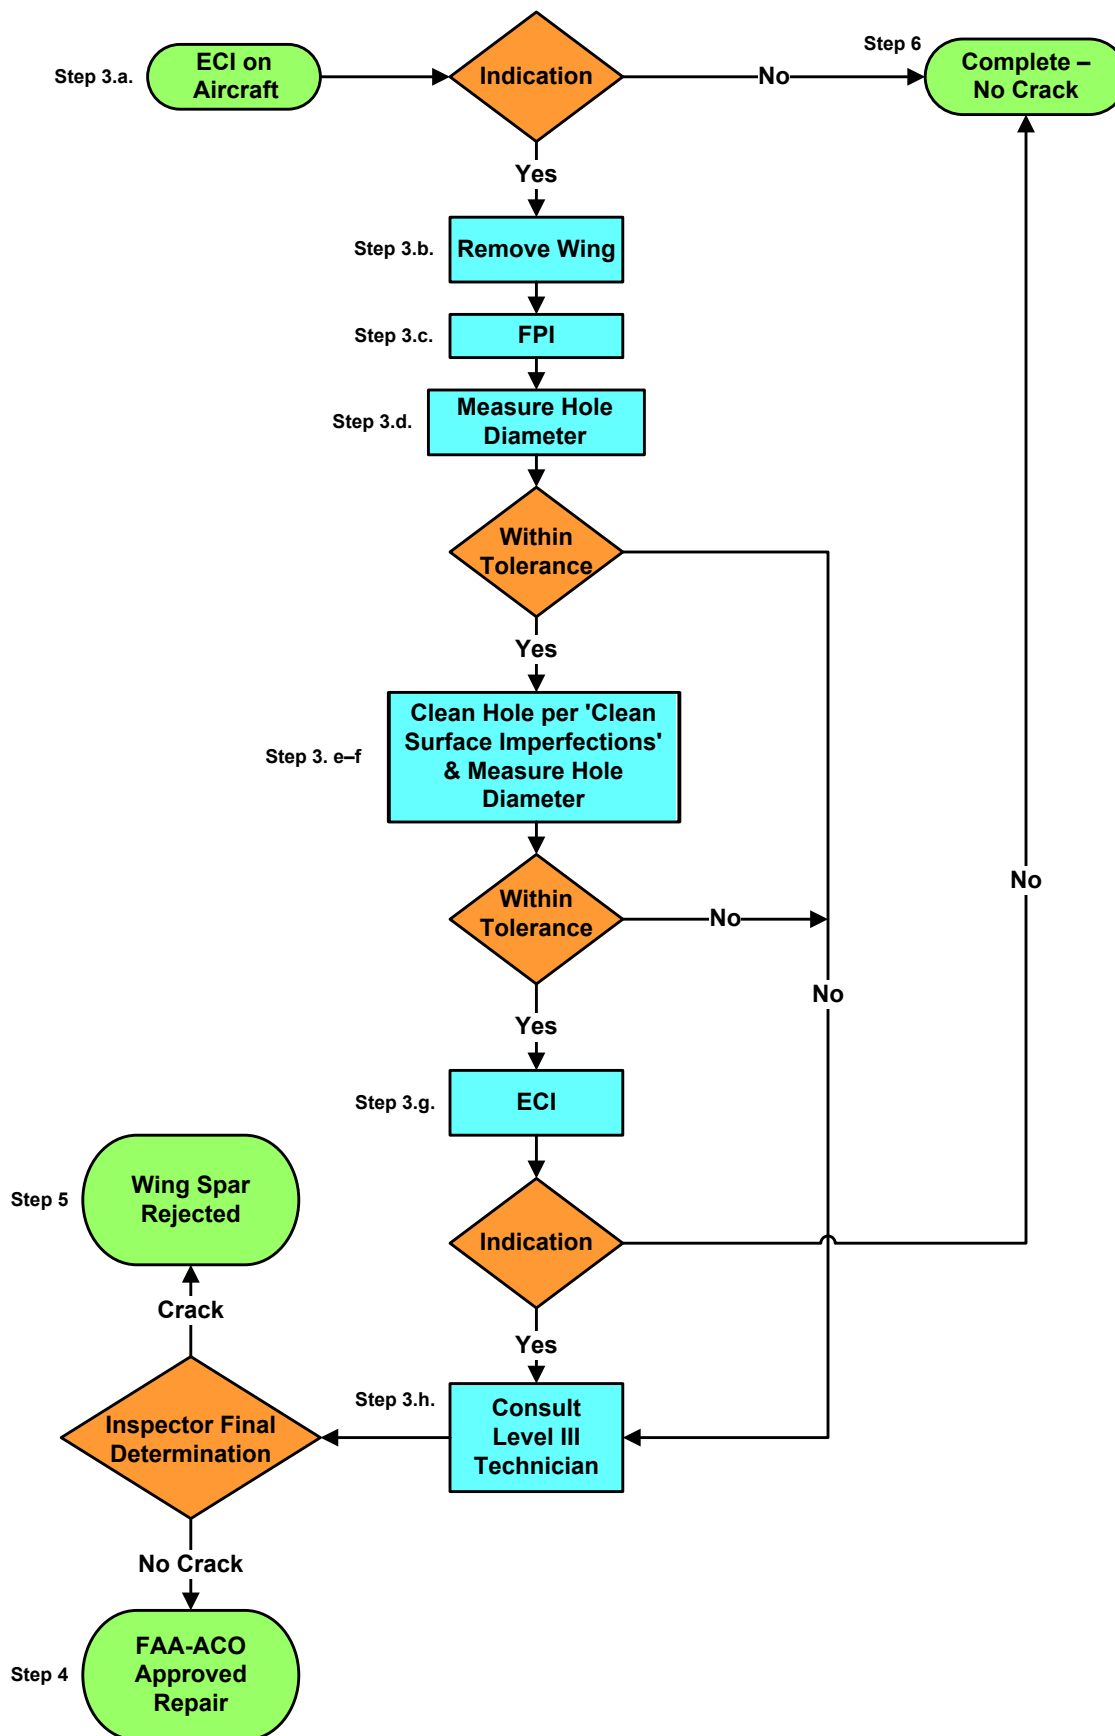
Typical Main Wing Spar Attach Bolts and Spar Cross Section (Right Wing Shown)

3. Inspect the inner surface of each bolt hole in the lower wing spar cap. Figure 1 provides cross sections of the main wing spar, and identifies the bolt hole inspection areas.

**NOTE:** When radius washers are properly installed, the radius feature of the washer will be oriented to match the radius of the adjacent structure, as shown in Figure 1, Detail D.
