Piper Aircraft, Inc.  
2926 Piper Drive  
Vero Beach, FL, U.S.A. 32960

# SERVICE BULLETIN

NO. 1372

### MAIN WING SPAR INSPECTION

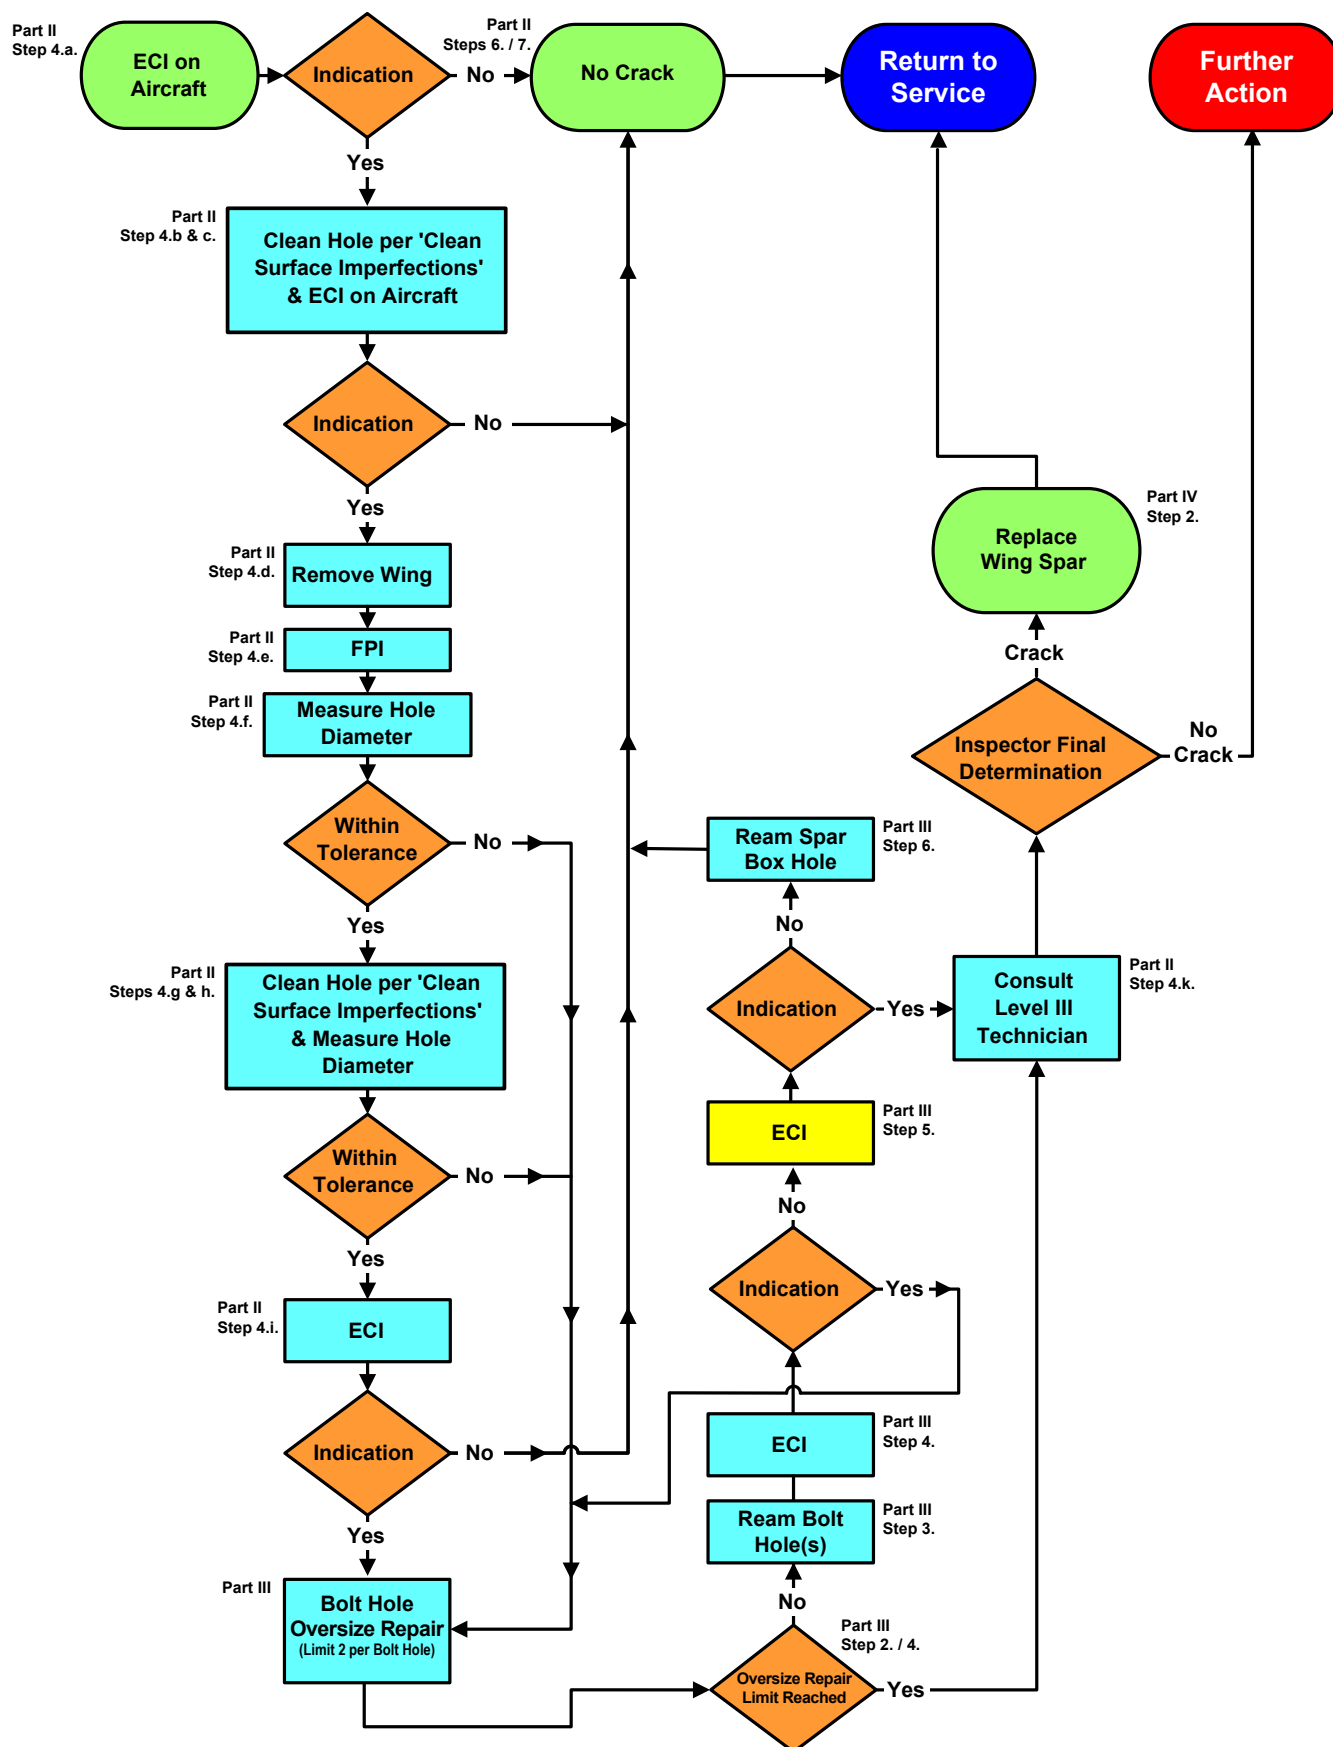
**Figure 2**  
Inspection Process Flowchart

**NOTE:** The inspection steps in these instructions are visualized in Figure 2, a process flowchart.
